Section 19 Flood Investigation Liverpool Road North – Maghull 10/11th August 2020

The purpose of this report is to investigate the flood events that triggered a section 19 report in Maghull overnight on the 10th/11th August 2020. Two locations in Maghull triggered the need for a section 19 investigation: businesses 1-39 Liverpool Road North and properties 187-197 Liverpool Road North.

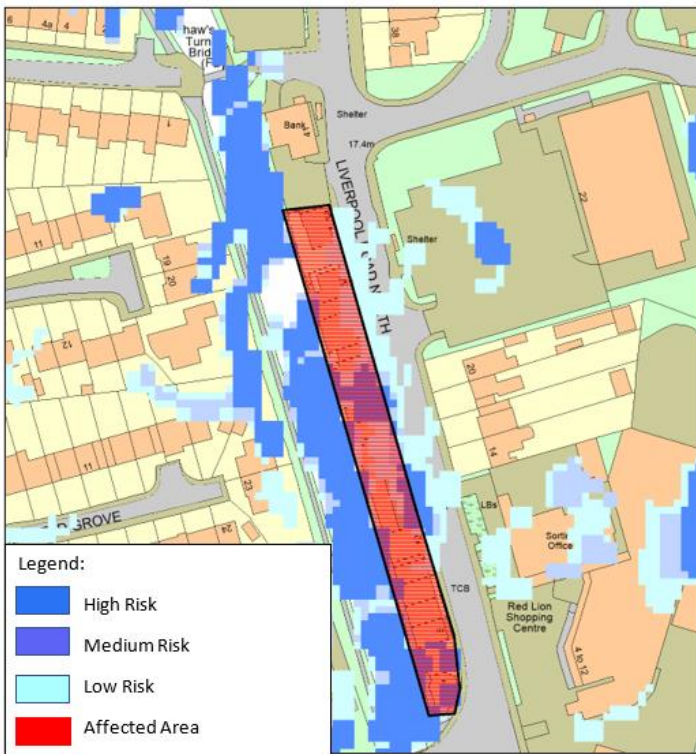
Figure 1 Surface water flood risk map for 1-39 Liverpool Road North

The surface water flood maps show that the area to the rear of the businesses (canal side) is at high risk and the highway is at medium risk with a few businesses at high and medium risk of flooding. The area that suffered from flooding is included on Figure 1. The surface water maps reflect the topography of the area as it is in a dip, as the opposite side of the road is higher and between Westway and the Red Lion Bridge all go down to the lowest point in front of the Number 15/17 .

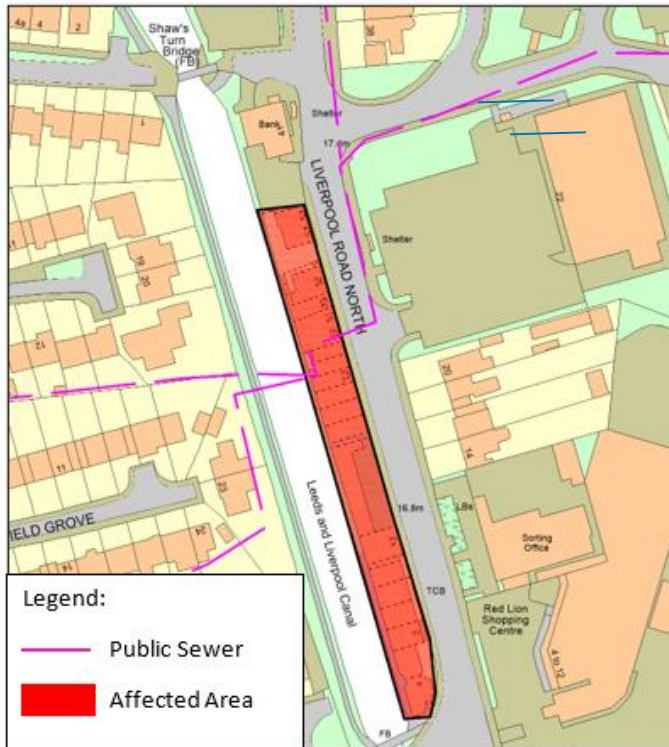
Figure 2 Drainage Network 1-39 Liverpool Road North.

The surface water public sewer drains an area between Westway and the Red Lion Bridge including Stafford Morton Way. Outside No.29 Liverpool Road North, the public sewer changes direction and flows towards the canal under the property. Behind No.25 the surface water sewer enters a combined sewer (foul and surface water) and there is a an overflow system and both systems go under the canal see Figure 2.

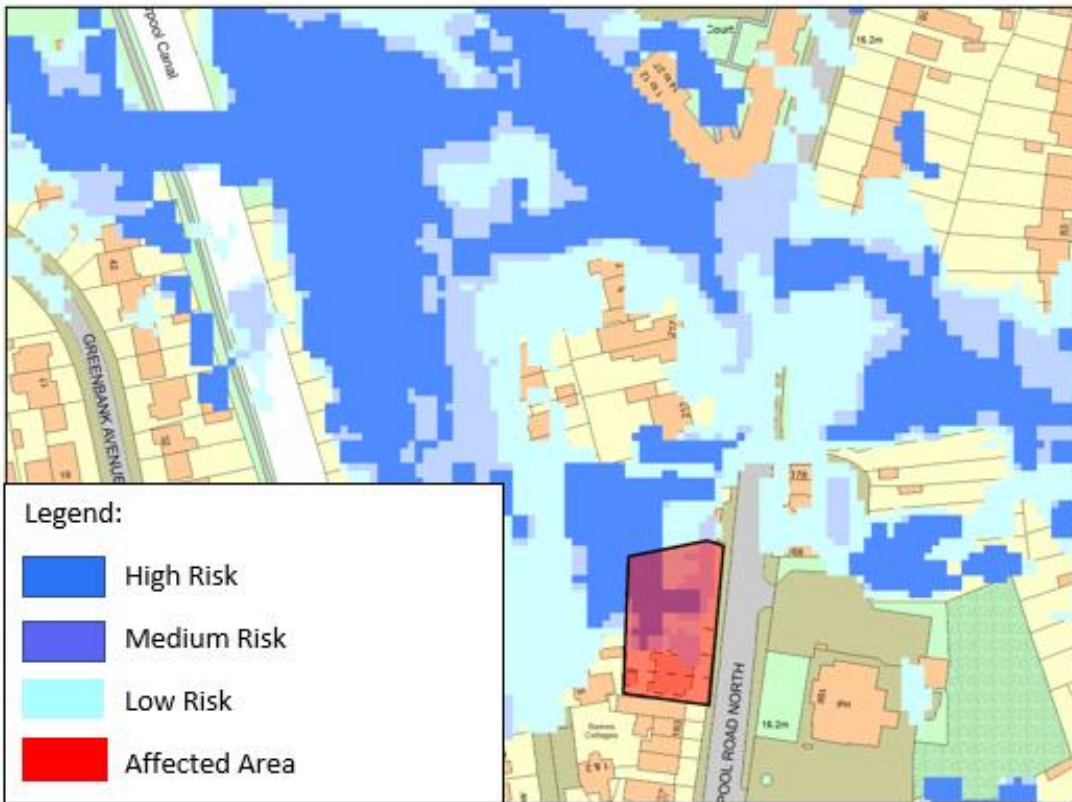
Figure 3 Surface water flood risk map 187-197 Liverpool Road North

The surface water flood maps (Figure 3) show that the area at highest risk is to the properties on Hickson Avenue. The map shows that the surface water flood risk to the properties on Liverpool Road North starts at No. 189 and is mainly low to medium risk running down the road to the junction with Liverpool Road. Again this surface water flood risk reflects the topography of the location with the lowest areas at highest risk. The area that suffered from flooding is included on Figure 3.

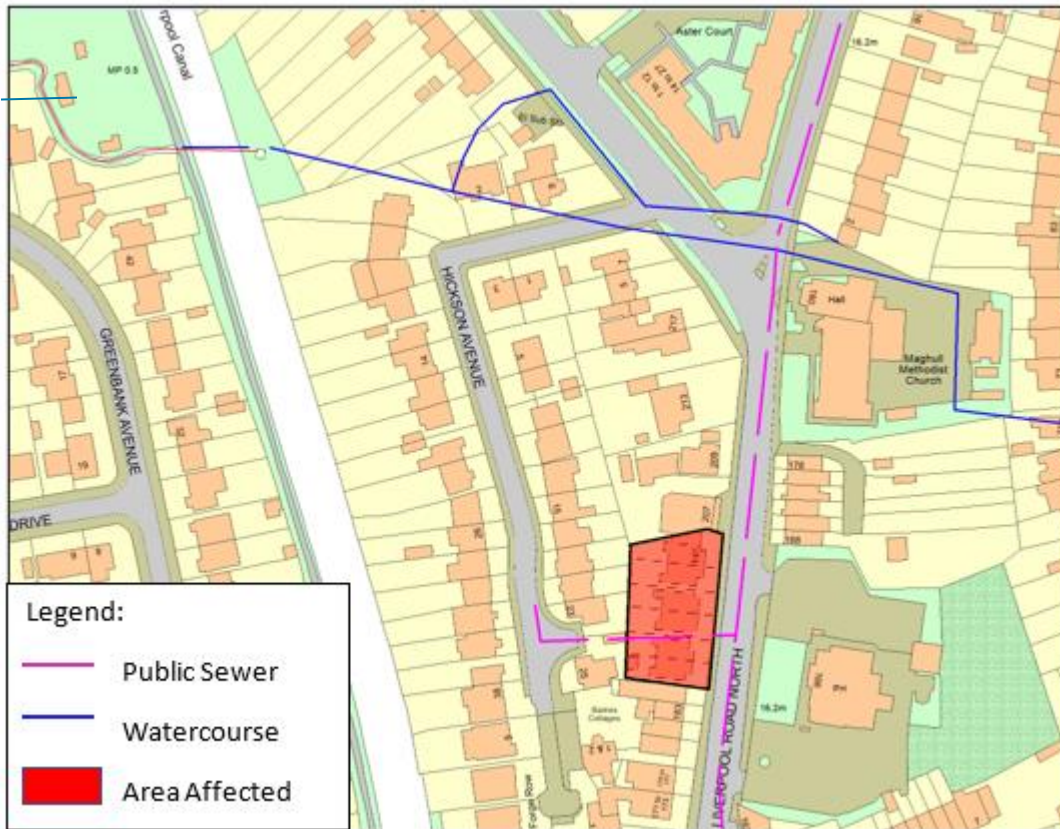
Figure 4 Drainage network 187-197 Liverpool Road North

The system that drains the area that flooded, between Green Lane and Southport Road, stretches from Westway to Nedens Lane with over 75 highway gullies. The surface water system starts as a highway drain flowing from Westway and becomes a public sewer where water from Granville Avenue enters it. At the junction of Southport Road, Liverpool Road North and Liverpool Road, the surface water sewers, draining the area, flow into a watercourse (Maghull Brook) and from there crosses under the canal. Figure 4

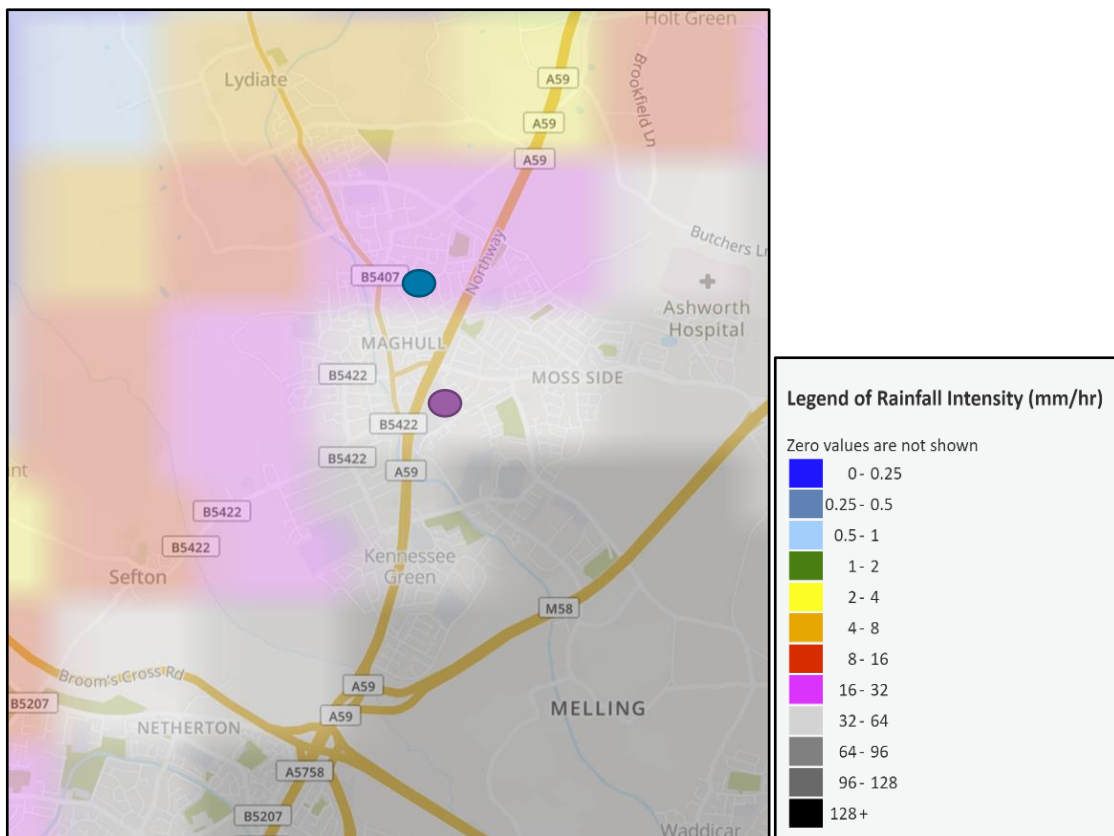
Figure 5 Rainfall radar (Source: Meniscus MapRain software) at 23:15 hrs. with legend

The storm was moving fast over the area in a northerly direction, affecting the southern site 1 -39 Liverpool Road first with light rainfall (2 – 4mm/hr) starting at approximately 23.00, but increasing intensity within 10 mins to between 32 – 64 mm/hr, seen in figure 5.

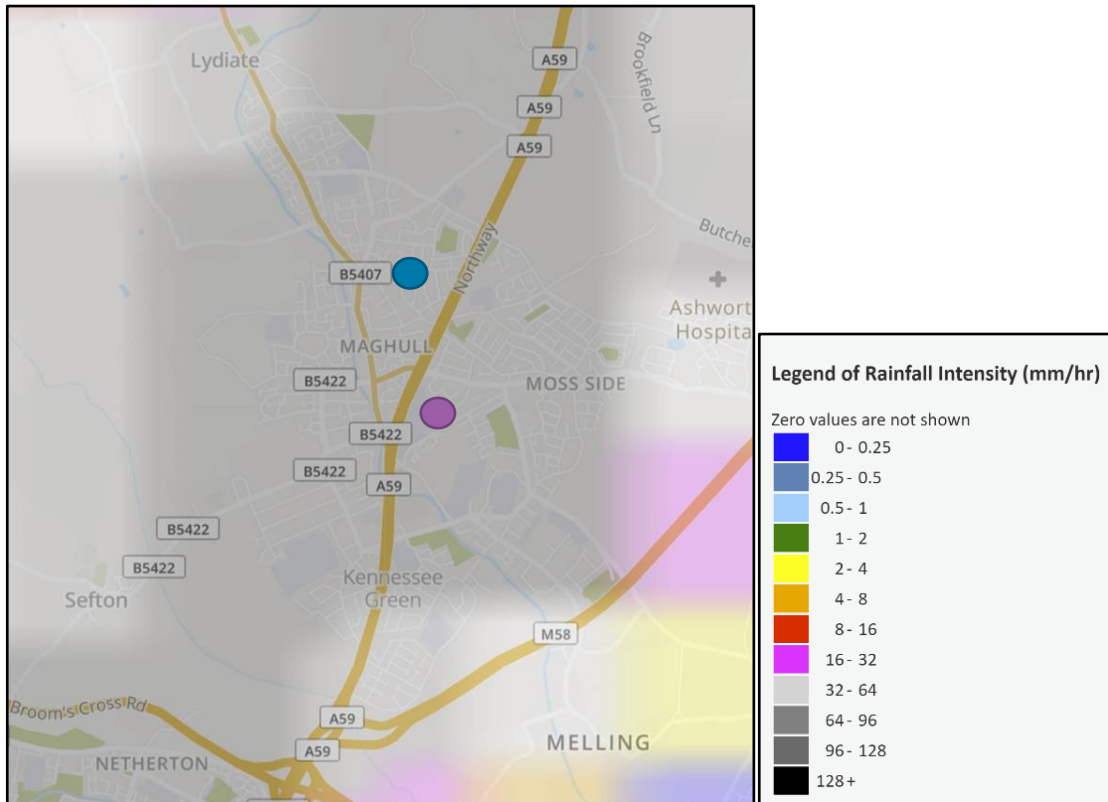
Figure 6 Rainfall radar (Source: Meniscus MapRain software) at 23:20 hrs. with legend

The radar picture (figure 6) at 23:20 shows the rainfall affecting the area to be between 64 - 96mm/hr. Again, this intense rainfall moves over the area fast and within 5 mins the rain fall intensity eases to 16-32 mm/hr, but this is still a significant amount of rainfall. The rainfall carried on affecting the area, at different intensities until 03.05hrs on the 11th August.

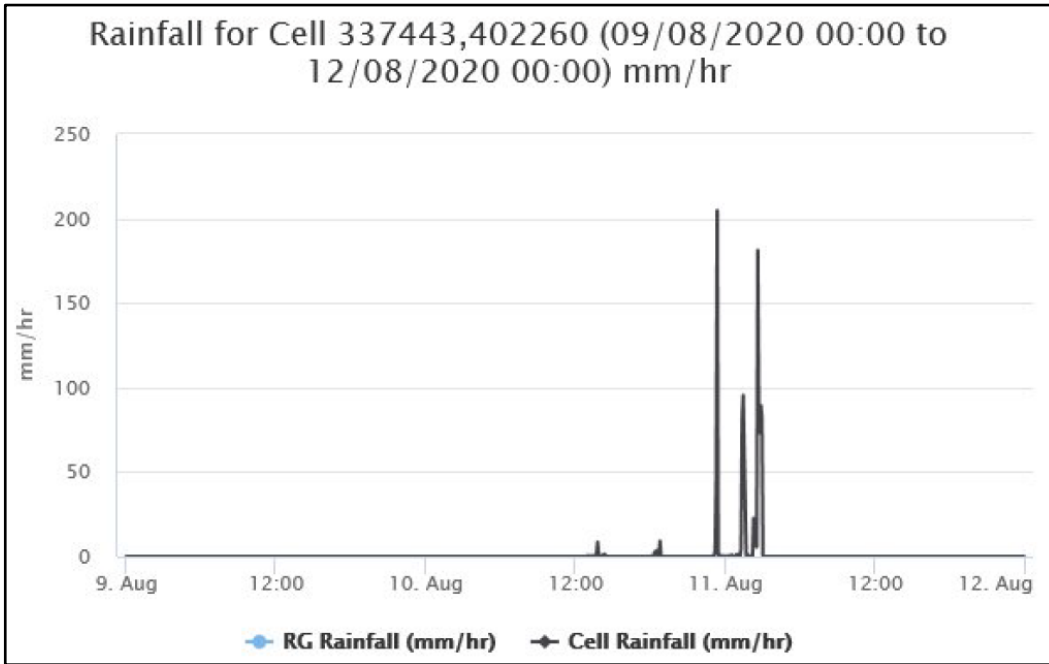
Figure 7 Rainfall amounts mm/hr. for 1 – 39 Liverpool Road North

As can be seen in the Figures 7 and 8, based on radar derived rainfall levels, the intense rain only lasted 15 minutes, but in that time over 20mm (2cm) of rain fell.

The return period calculated for 1-39 Liverpool Road North is 24.20, which translates into a 4% chance of this type of rainfall occurring in any one year. Whilst the return period for 187-197 Liverpool Road North is calculated at 30.57 or just over a 3% chance of this type of rainfall occurring in any one year.

Start of peak rainfall	10/08/2020	23:15 hrs
End of peak rainfall	10/08/2020	23:30 hrs
Duration (mins)		15
Rainfall depth (mm)		20.95
*FEH **return period		24.20

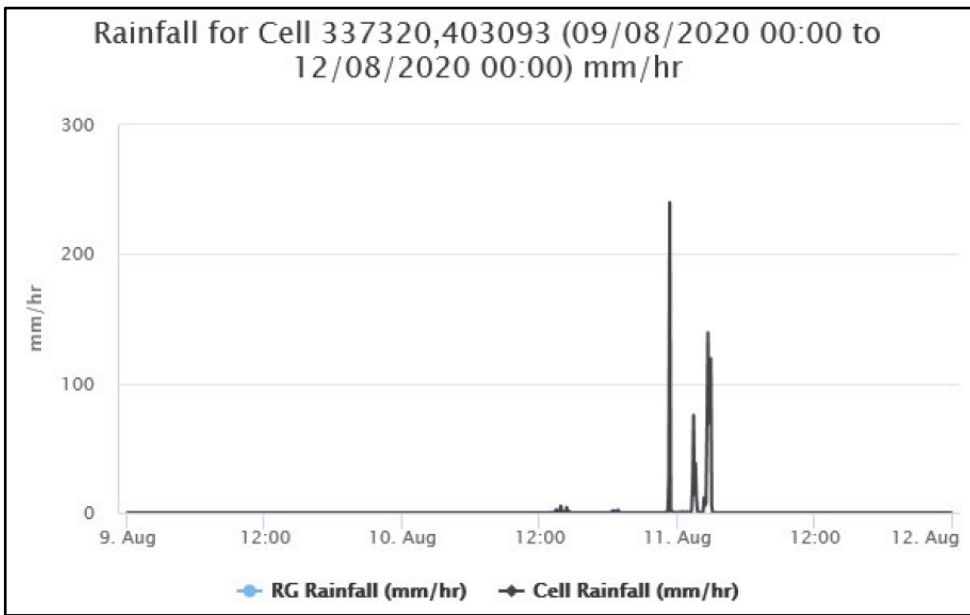
Figure 8 Rainfall amounts mm/hr. for 187 - 197 Liverpool Road North

Start	10/08/2020	23:15 hrs
End	10/08/2020	23:30 hrs
Duration (mins)		15
Rainfall depth (mm)		22.33
FEH return period		30.57

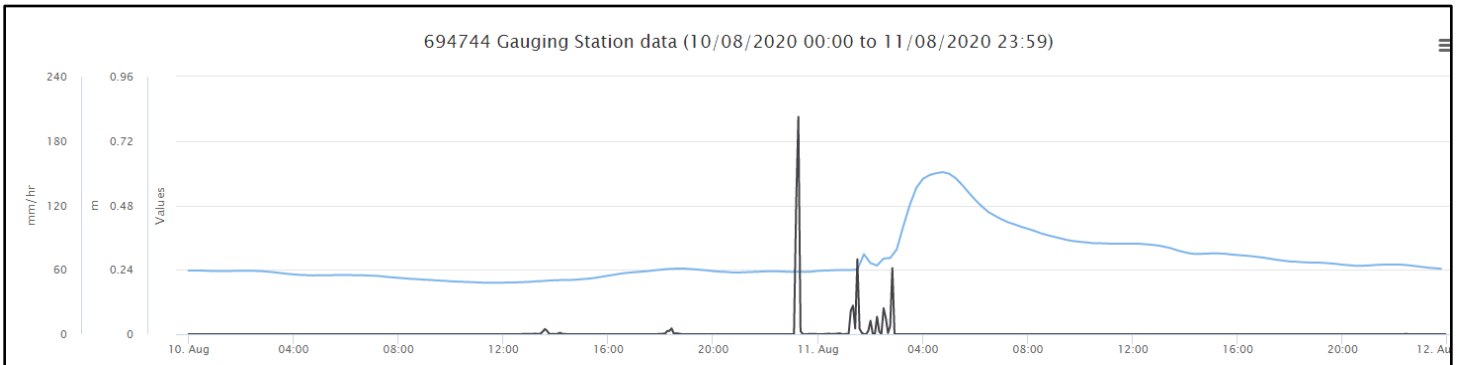
Figure 9 Rainfall and river gauge levels for the River Alt

The flooding was not related to watercourses, however, it is interesting to note that the rainfall event was significant enough to raise the river levels in both the River Alt by 37cm (Figure 10) and Dovers Brook by 80cm (Figure 11).
