**BUILDING CONDITION SURVEY
REPORT
TOAD HALL, SHORE ROAD,
AINSDALE,
PR8 2PZ
SEFTON COUNCIL
17th July 2024**

SEFTON COUNCIL

17th July 2024

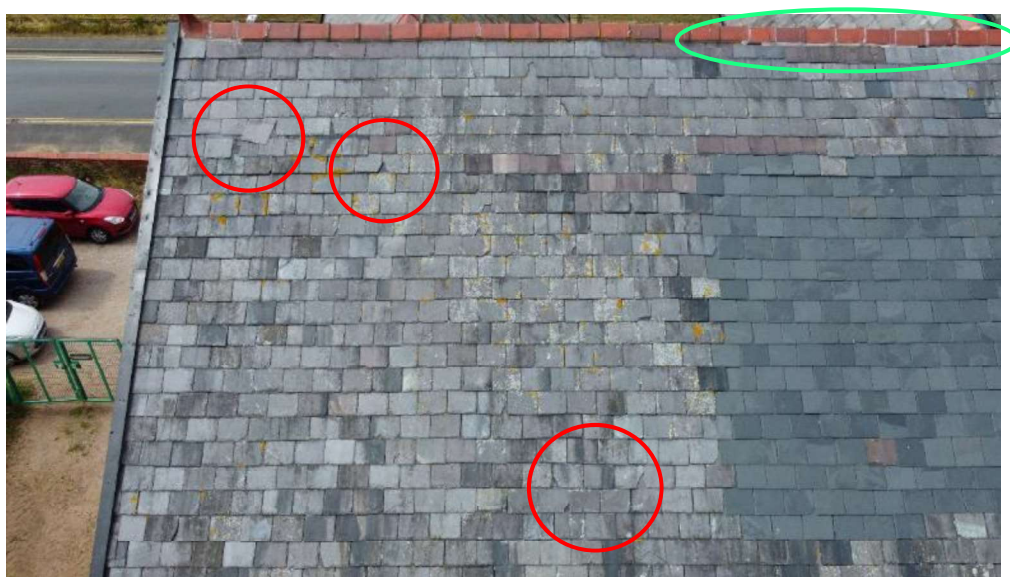
The main roof is a duo pitched roof with dormers to front and side elevations, formed with a natural slate covering and clay capped angle ridge tiles. The structure of the roof would appear to be in fair condition with no signs of any significant deviation to the ridge or roof slopes. We noted areas of contrasting newer slates, including a large proportion to the rear slope and small localised areas to the front slope, as well as repointing to numerous areas of the clay ridgeline (example highlighted in green – *figure 2*), where it appears a repair scheme has been undertaken. However, remaining areas of the roof covering showed signs of deterioration, shown in *figures 2 and 3*, where numerous slates have slipped and become dislodged or are chipped/cracked, particularly to slate corners. While works have clearly been undertaken recently to repair the roof covering, would advise that if the property is to be renovation for occupation the roof covering will require renewing in full.

Figure 2: Aerial view showing condition of rear pitched roof.

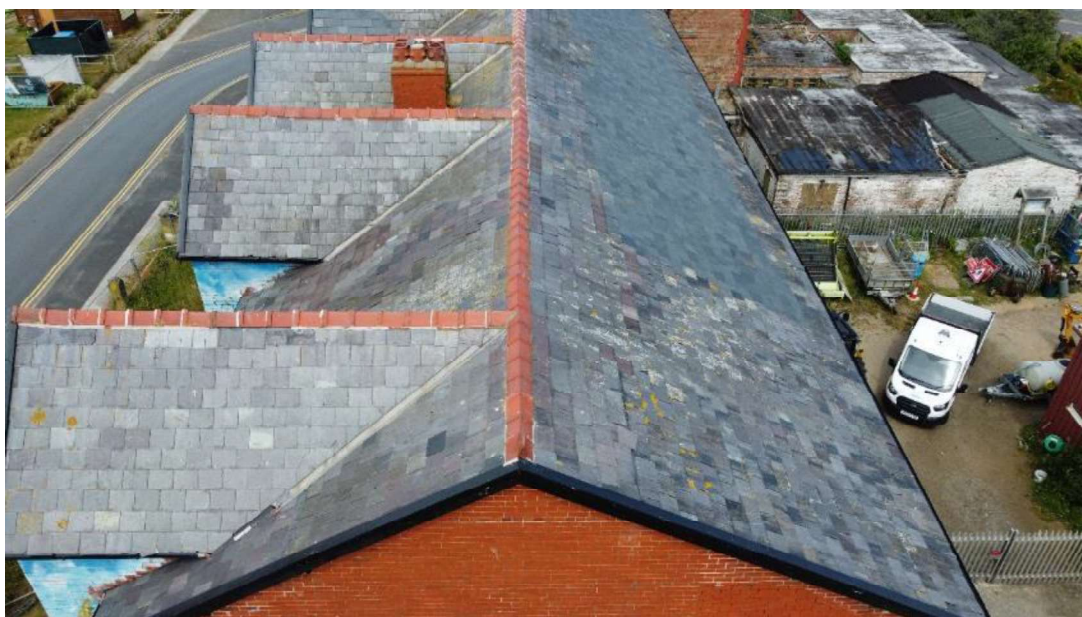
Figure 3: Aerial view showing general condition of roof pitched roof covering.

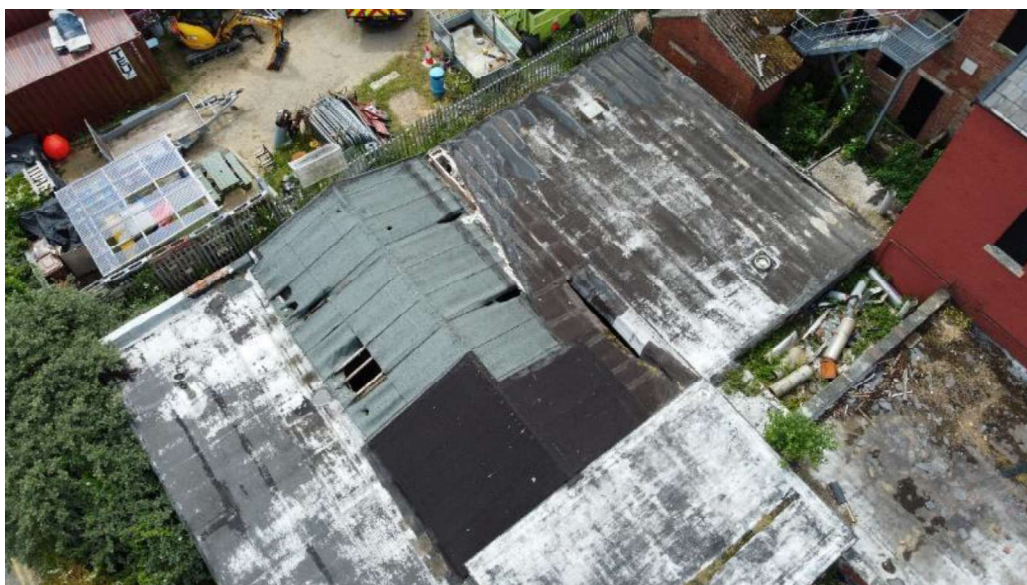
As shown in *figure 4* below, the flat roof covering to the rear extension is poor condition. The felt covering to the low pitched area towards the centre of the roof is heavily worn and the structure has and partially collapsed. There are numerous localised areas to the remaining flat roof sections in which the timber structure is exposed, presumably as a result of water penetrating defective felt joints over time causing the adhesion between layers to deteriorate. We noted an area of patch repairs to the central pitch, where new felt has been installed, however it is clear that due to poor condition, the roof covering would require renewing in full. We expect the whole roof structure is also extensively damaged beyond repair so will also require replacing in full.

Figure 4: Aerial view showing general condition of flat and low pitched roofs to the rear extension. Each building has an entrance porch configured with a timber flat roof structure covered with felt, atop stonework columns. As shown in *figure 5*, flat roofs to entrance porches were either in a state of disrepair or had collapsed completely so all will require new timber roof structures and waterproof coverings.

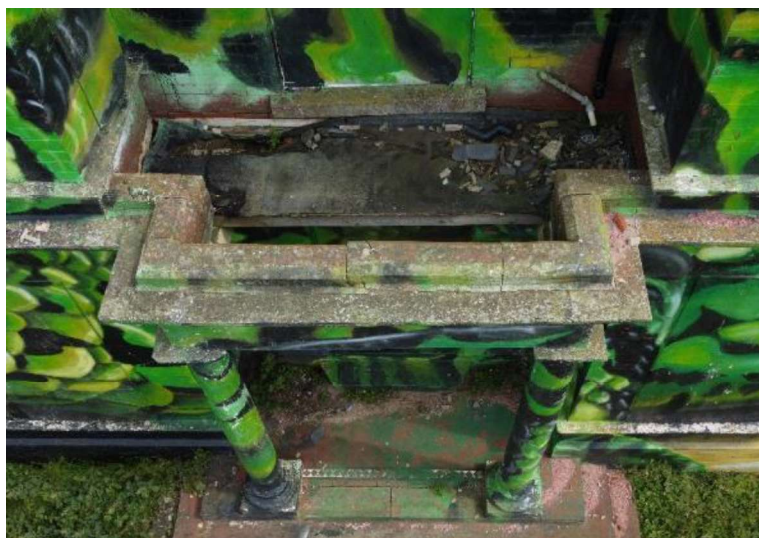
Figure 5: Failure of flat roof to entrance porch (front elevation).

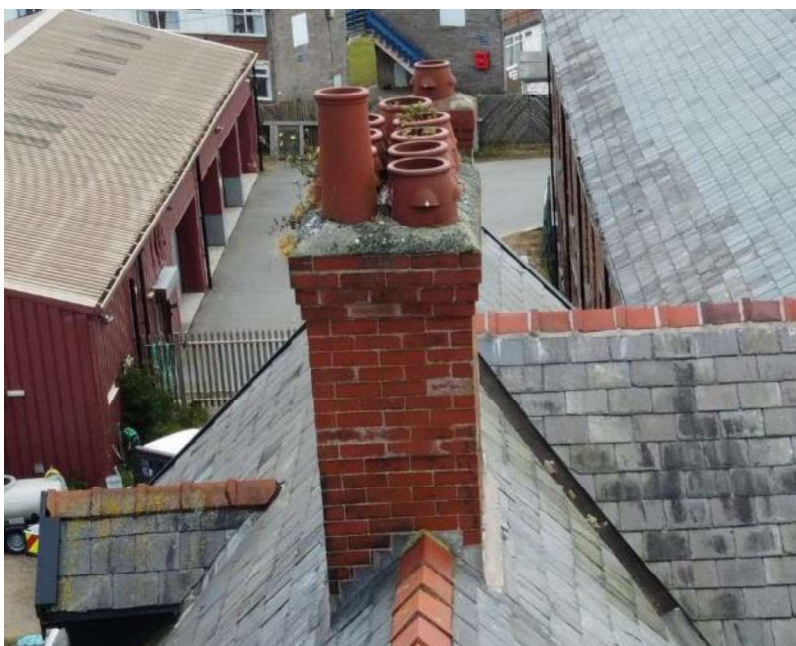
The main pitched roof has 6 brick chimney stacks of varying sizes, all with clay pots bedded in in cement flashing. A very slight lean was noted to top thirds of the large 9 pot chimney stack to ridge of Building 4 as shown in figure 6 below. The remaining chimney smaller stacks appear to be plumb. Cracking and vegetation growth was noted to the cement flashing. Slight vegetation growth noted to brickwork pointing indicating requirement for localised patch repointing.

Figure 6: Slight lean to top third of chimney stack. Plant growth to pots and flashing. Most of the pots are not capped off and have plant growth as shown in figure 7 below.

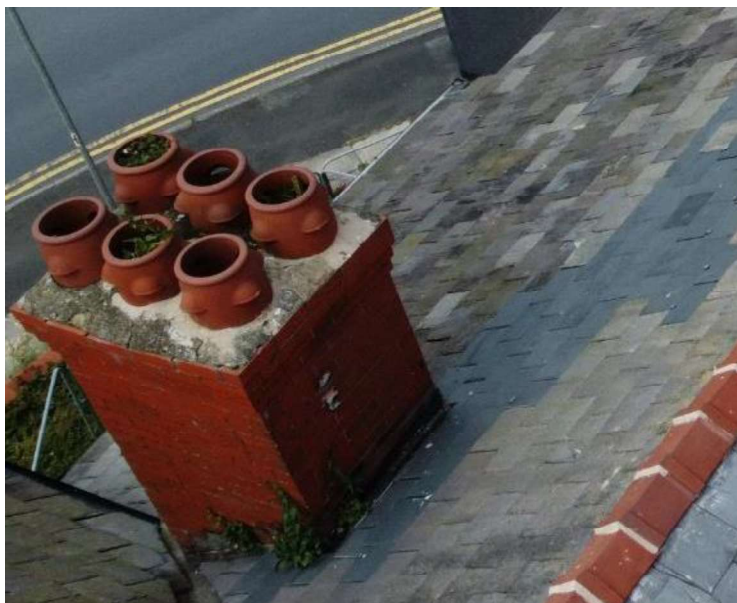
Figure 7: Mixture of capped and uncapped chimney pots.

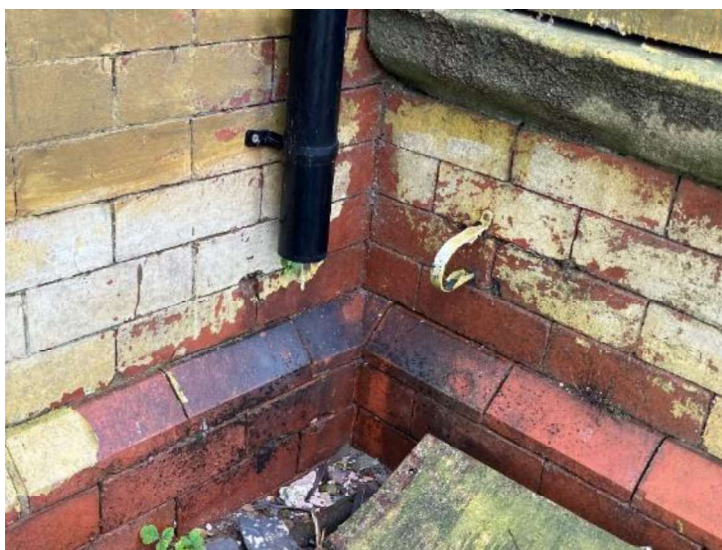
Rainwater goods to the front and rear elevations are uPVC gutters and downpipes, which appear to have been newly installed within the last few years. The joints between sections of guttering appeared to be in good condition, however as our inspection was carried out during a spell of dry weather, the effectiveness of the joints in providing a watertight finish could not be established. As shown in *figure 8*, we also noted that downpipes to the front elevation are not connected to a recognised below ground drainage system, subsequently allowing rainwater to drain directly onto the brickwork / ground below, which can cause the ground to become saturated during periods of heavy rainfall leading to the possibility of ground movement and subsidence and heave structural issues to the building.

Figure 8: Lack of sufficient drainage system to downpipes.

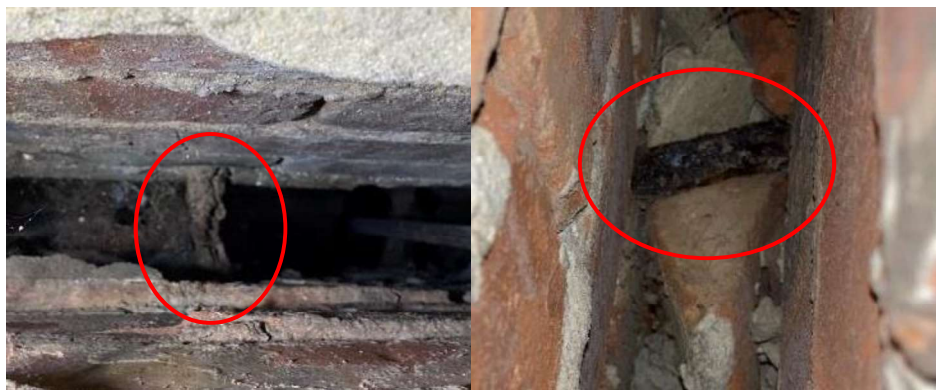
The external elevations are configured with two layers of masonry separated by a circa 50mm cavity. As shown in *figure 9*, metal wall ties have been used to join the two leaves of the cavity wall together. However, these are now heavily corroded. Expansion of the wall ties is likely a contributing factor to the horizontal cracking noted to walls externally, and they would require replacement in order to maintain the structural integrity of the brickwork external walls.

Figure 9: Corroded wall ties to cavity wall (front elevation).

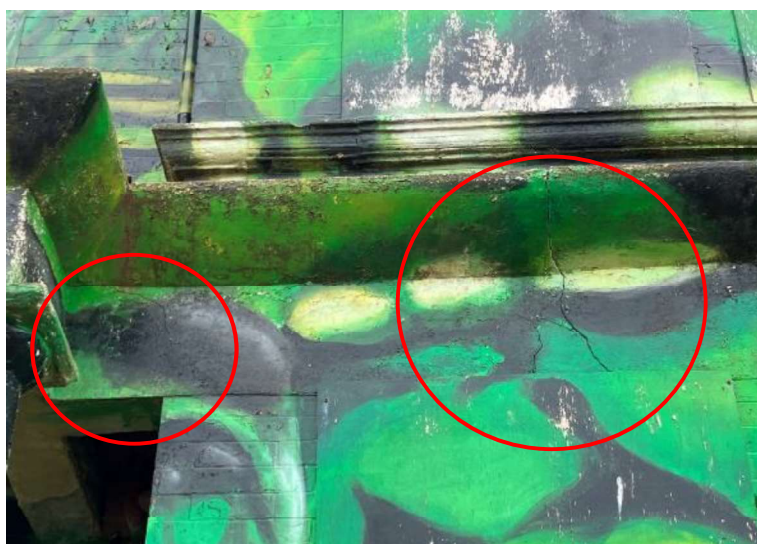
We also noted localised areas of cracking to masonry walls and stone heads / sills to the front elevation, shown in *figure 10*, as well as areas of stepped cracking / movement through mortar joints to low level brickwork, shown in *figure 9*. This type of cracking is typically indicative of ground movement, and we would suspect requirement for some form of strengthening works to the foundations (i.e. underpinning) may be required as part of any renovation works in addition to masonry repairs (i.e. crack stitching) to ensure the stability of the building.

Figure 10: Cracking to stone sills (front elevation).

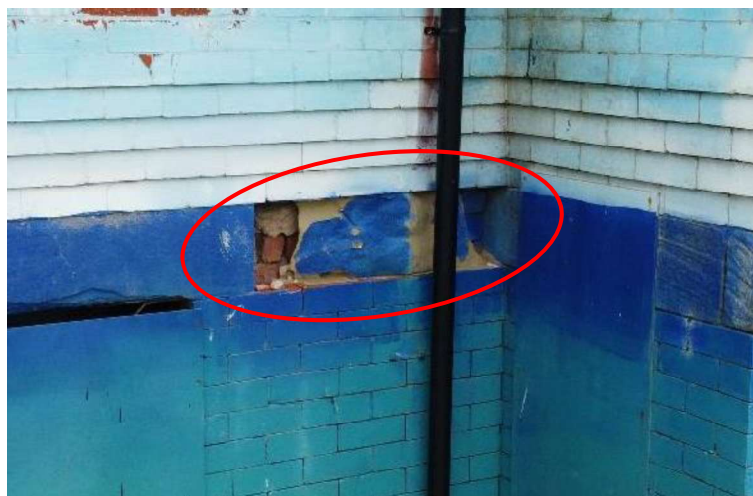
Figure 11: Erosion of stonework bank course to front elevation

Localised areas of extensive erosion were noted to stonework detailing to the front elevation as shown in *figure 11*. This erosion is expected to have occurred as a result of the prevailing weather conditions to the exposed beach front location. Sections of badly eroded stonework will require cutting out and replacing.

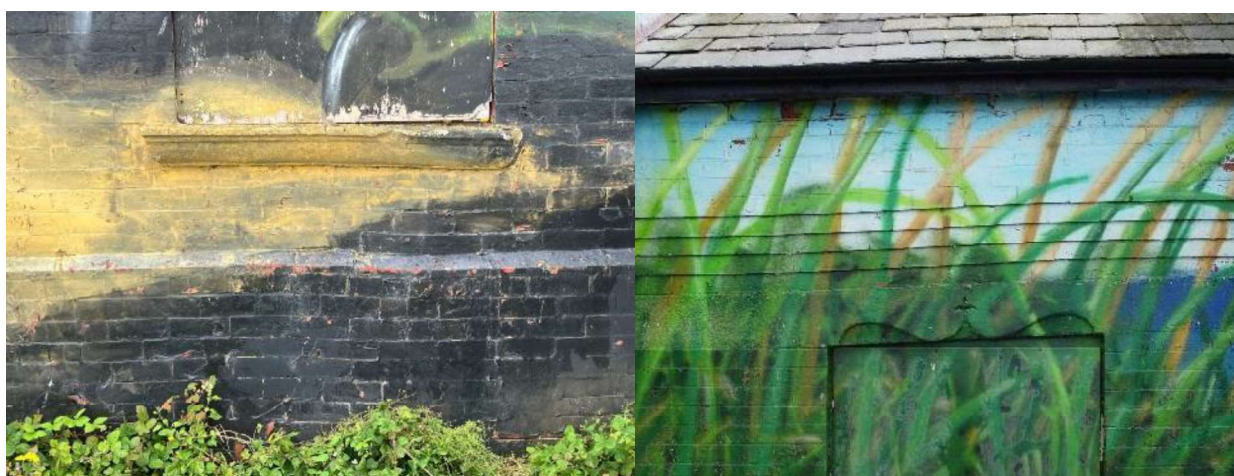
Figure 12: Uneven brick courses to front elevation.

The main building frontage was noted to have suffered structural movement with uneven brick courses to the elevation close to ground level and below roof level. This movement does not appear to have occurred recently but has most likely occurred due to structural ground movement affecting the building foundations. Further signs of structural movement were noted to the front elevation in the form of stepped cracking as show in *figure 13*. Rainwater discharge from downpipes not directed into the underground drainage system is potentially the cause of this however, we would recommend further intrusive investigation of the building foundations and ground conditions by a structural engineer.

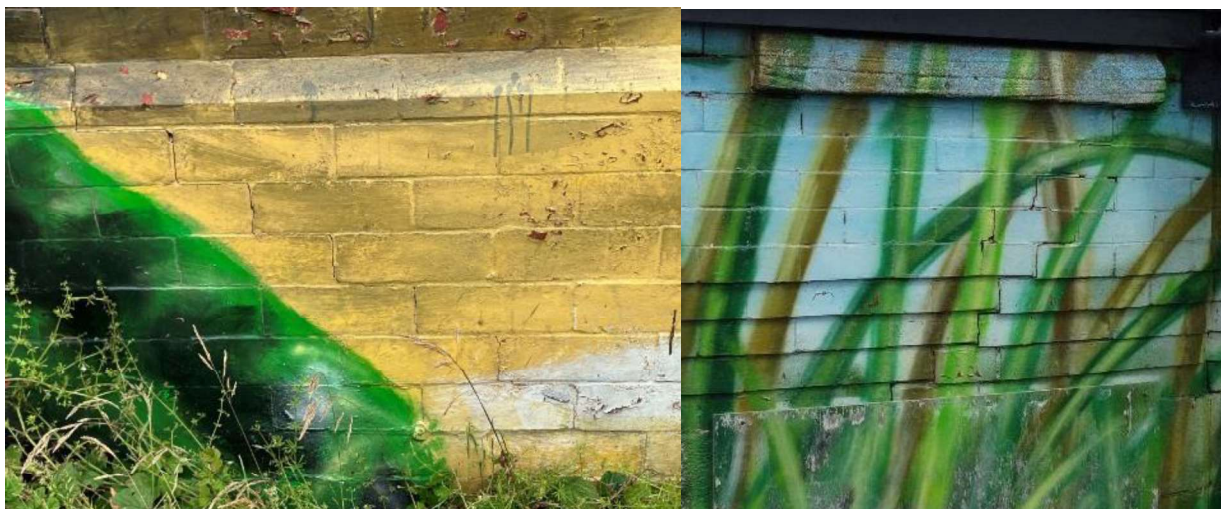
Figure 13: Stepped cracking through brickwork mortar joints (front elevation).

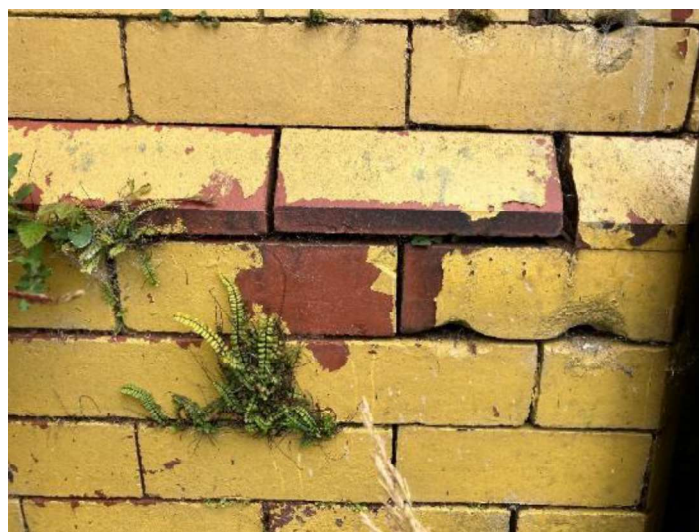
Localised decayed pointing was noted to all elevations, shown in *figures 14 and 15*, along with various sections of patch repointing to front and rear elevations. The presence of decayed mortar can allow the build-up of moisture behind a wall, encouraging dampness which over time can cause wall ties to fail, and generally compromise the structural integrity of the wall. Decayed pointing requires attention to numerous areas, and we would therefore advise fully repointing brickwork to all elevations in lime-based mortar.

Figure 14: Decay of mortar joints (front elevation).

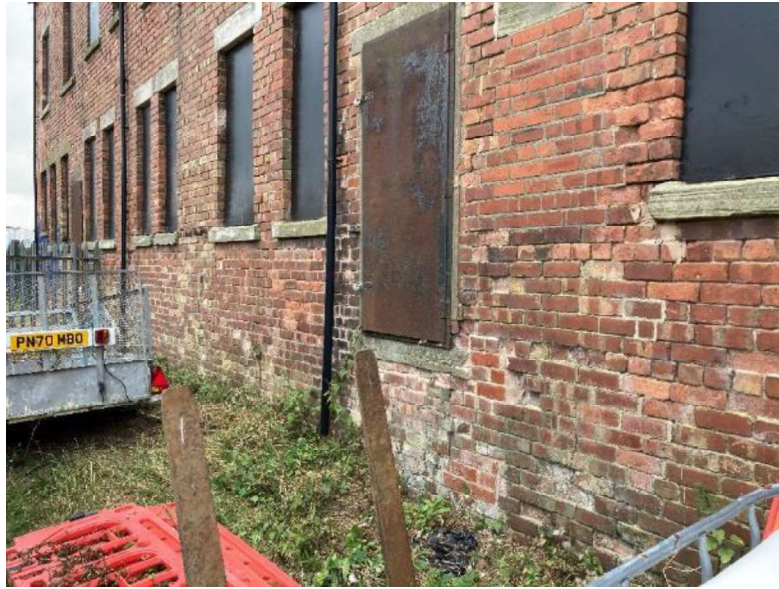
The external brick walls were also spalled to localised sections, likely due to pre-existing decay of mortar joints causing increased moisture movement through the brickwork and the facings of bricks to become spalled. If left unremedied, spalled brickwork can become a significant structural issue and we would subsequently advise severely spalled sections of brickwork require repair / replacement.

Figure 15: Spalling/cracking to brickwork and decay of mortar joints (rear elevation).

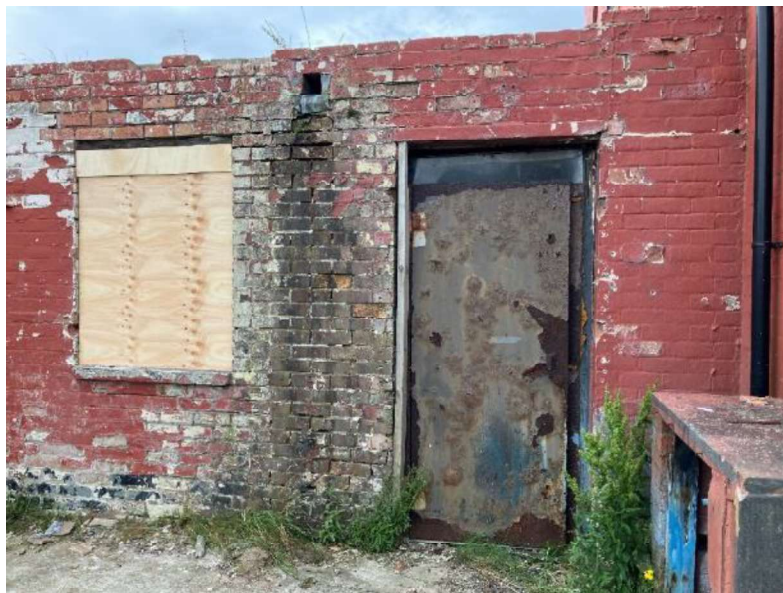
We noted similar issues to external walls of the rear extension, where there was significant lack of a sufficient drainage system. As shown in *figure 16*, there is no downpipe installed to the front elevation of the rear extension, causing rainwater to flow from the internal guttering system directly onto the brickwork below. This has caused dampness, staining, moss growth and spalling to brickwork as well as decay of mortar joints.

Figure 16: No downpipe installed to rear extension resulting in deterioration of brickwork.

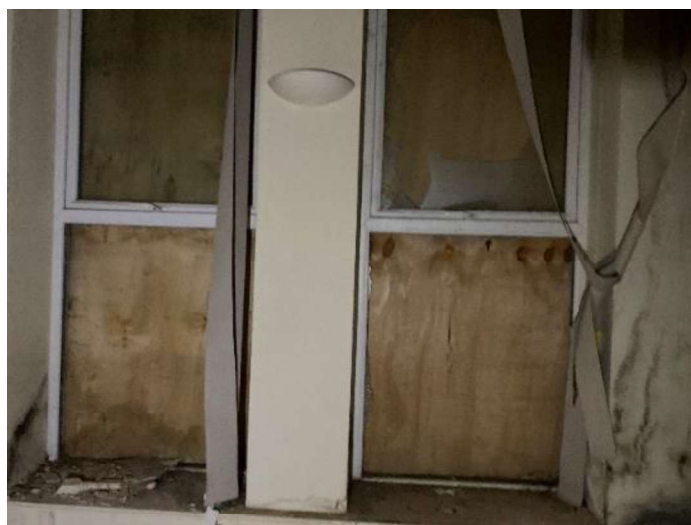
Double glazed uPVC windows have been installed to building 3 and 4 as shown below in figure 17 below however a large number of the glazing units are damaged or missing completely.

Figure 17: Failed glazing units to ground floor uPVC windows, Building 3.

We would advise full replacement of windows will be required. It should also be noted that during replacement works, it is likely that timber lintels are likely suffering timber decay and will also require replacement.

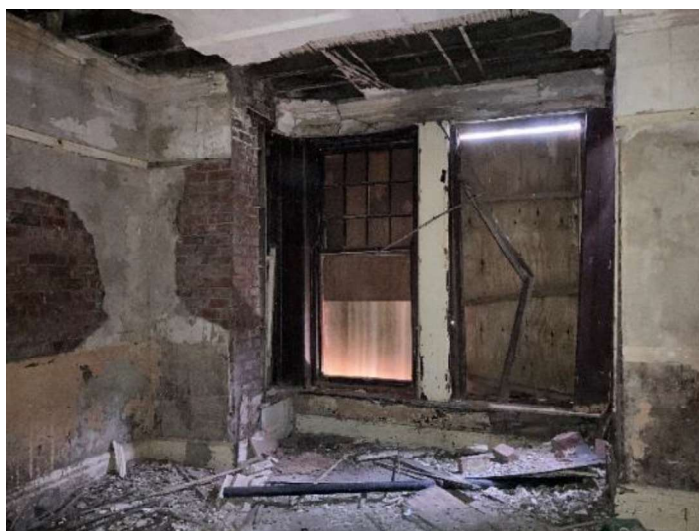
The remainder of the windows are single glazed painted timber sliding sash windows, which are all in poor condition as shown in figure 18. Most glazing panels are either damaged or missing, and the timber frames are predominantly suffering timber decay. In some cases windows have become detached from the window reveals, presumably as a result of decay. We also noted penetrating dampness to surrounding plaster reveals, confirming the window frames are no longer watertight.

Figure 18: Severe deterioration of timber windows to Building 1, ground floor.

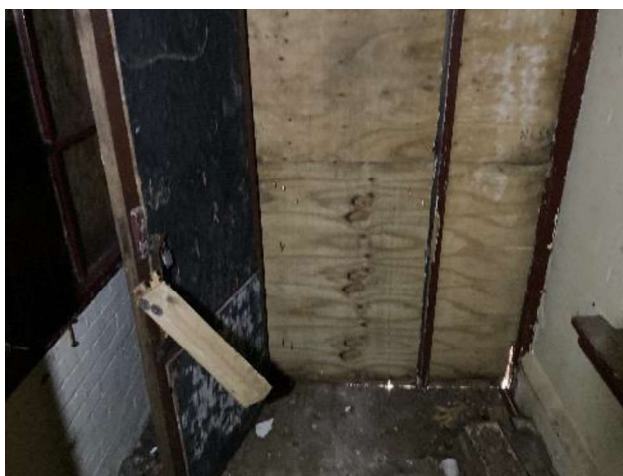
External doors were also boarded externally which limited full external inspection. Internal inspections confirmed painted timber single glazed entrance doors. All doors are generally in poor condition with damaged and missing glazing as shown in figures 19 and 20. None of the single glazed timber door meet current thermal insulation requires of the Building Regulations so we would expect all will require replacing as part of any refurbishment proposals.

Figure 19: Building 4 front entrance.

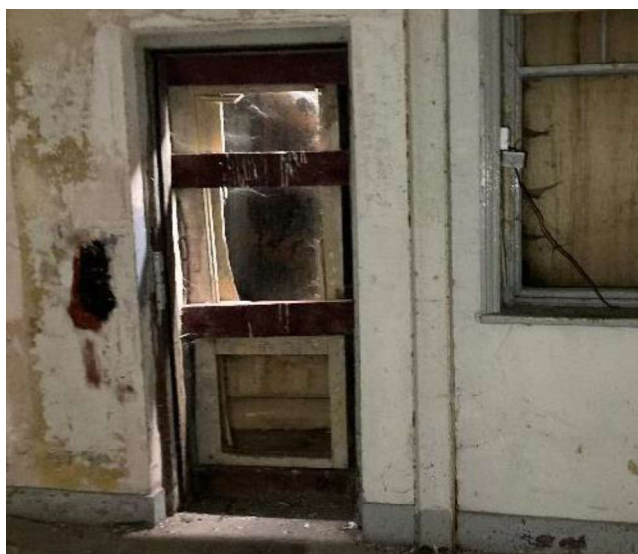
Figure 20: Building 2 rear entrance.

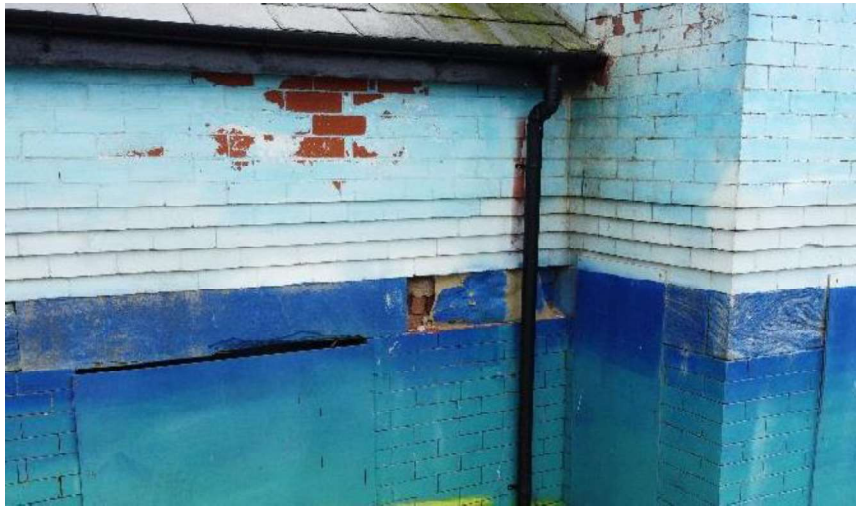
Generally external decorations timber fascia and bargeboards is in fair condition. The paint finish to the front facing brickwork elevations forms a decorative mural by local artist Paul Curtis. The paint finish is slightly worn as show in figure 21 below areas however we assume the mural is a temporary installation and paintwork applied to brickwork would need to be removed or redecorated as part of any refurbishment proposals.

Figure 21: Worn paint finish to decorative mural.

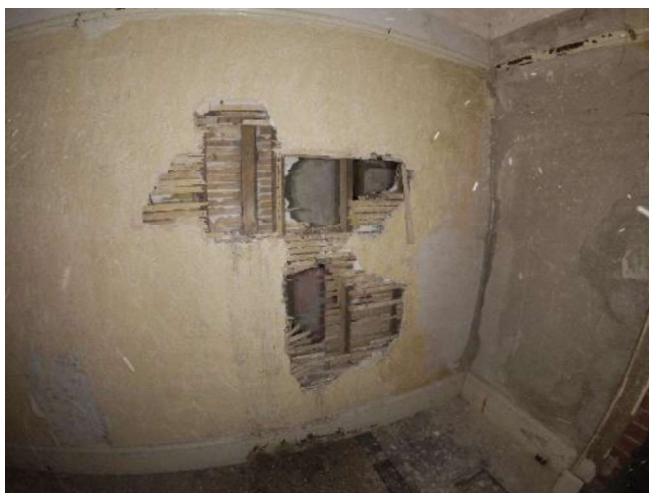
Although internal wall surfaces were mostly plastered or concealed by lining/decoration, we still noted a number of defects to walls internally, including the partial collapse of a lath and plaster partition wall to the first floor, which has likely decayed as a result of prolonged moisture exposure, leaving a large hole in the wall. It is likely the partition wall will need to be fully replaced as a result of suspected timber decay.

Figure 22: Partial collapse of lath and plaster partition to first floor.

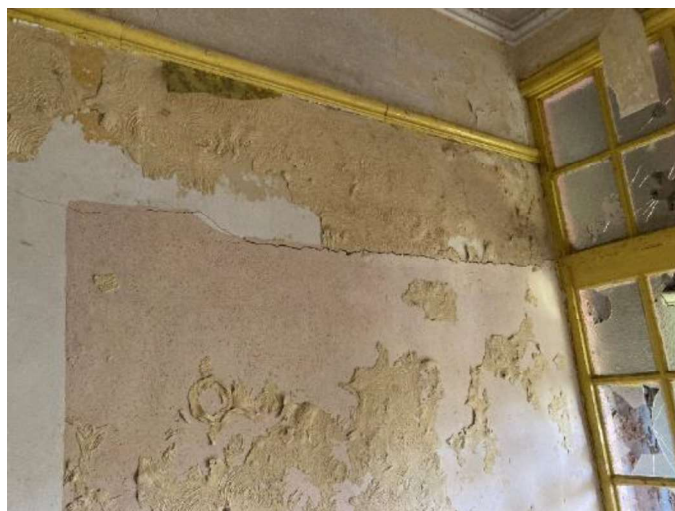
Cracking was identified in various areas, including a moderate horizontal crack to the hallway wall on the ground floor, shown in *figure 23*. Although the cracking noted could be indicative of other issues relating to the property being vacant for an extended period, causing lack of climate control, multiple cracks were inspected both internally and externally to various areas around the property, which likely indicates structural foundation movement issues.

Figure 23: Horizontal cracking to ground floor wall.

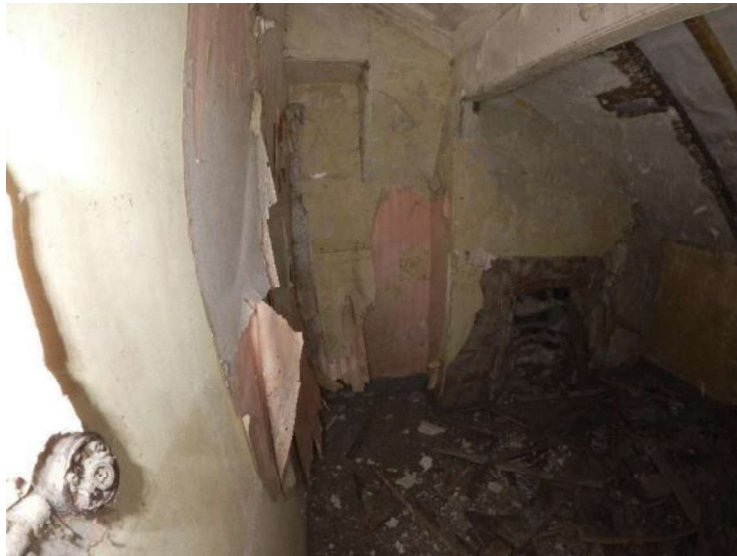
Deterioration of internal wall finishes was noted all round the property, as shown below in *figure 24*, including peeling wallpaper, deterioration of plasterwork, staining and mould growth, which would all indicate high levels of moisture to walls internally. We would advise that almost all plasterwork requires removing and replacing due to the poor condition of the plasterwork, and to allow full inspection of the brick substrate.

Figure 24: Deterioration of internal wall surfaces (second floor).

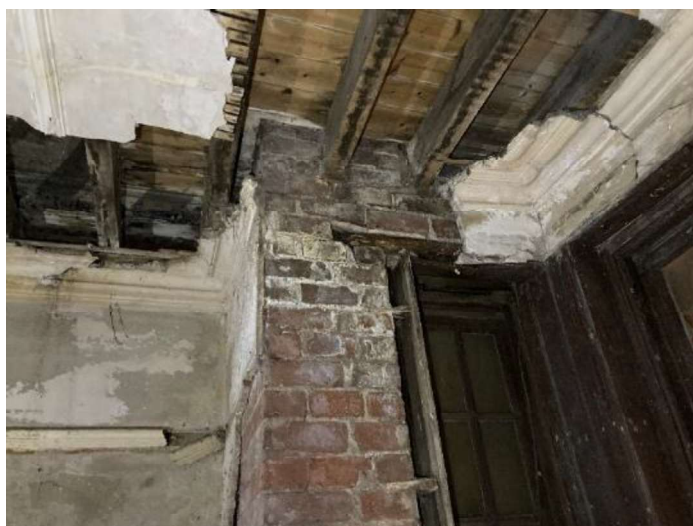
It appears the original lath and plaster ceilings mostly remain throughout the property. As seen below in *figure 25*, a large proportion of the lath and plasterwork to the ground floor ceiling is missing, a common defect we noted to multiple areas throughout the buildings. Due to high levels of moisture internally, the plaster can become brittle and crack in areas which have suffered water damage, and if left unremedied, the plaster can begin to sag and even collapse where the damage is extensive, which we have noted here and in various other areas. This has left timber ceiling joists and floorboards exposed.

Figure 25: Failure of ground floor ceiling.

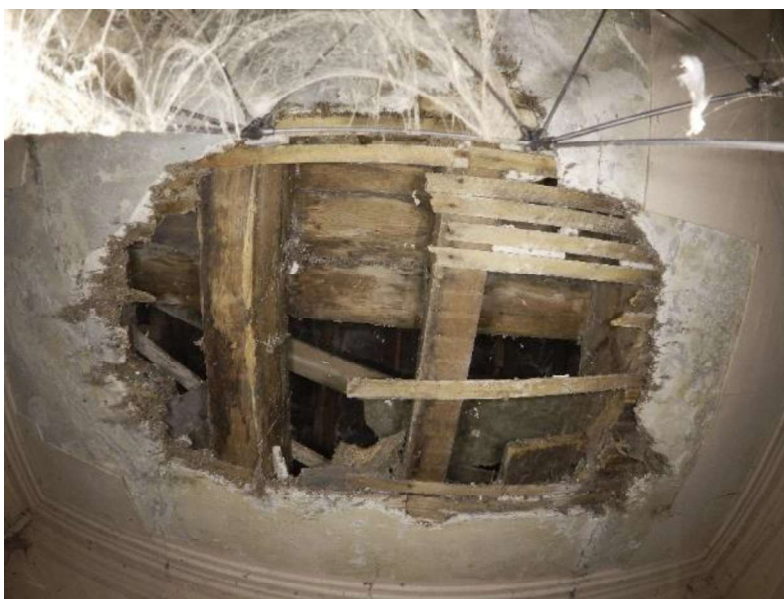
A similar issue was identified to the first floor, which has again resulted in the collapse of the ceiling finish as seen below in *figure 26* where ceiling has been lined with plasterboard. Where the plaster has collapsed, pre-existing deterioration of the timber can be seen, including staining and suspected dampness. We would therefore recommend that all ceilings are removed to allow for full inspection of the floor joists and to expose all decayed timber, allowing repairs to be undertaken. We would anticipate that a large proportion of the timbers will require replacement.

Figure 26: Hole to first floor ceiling.

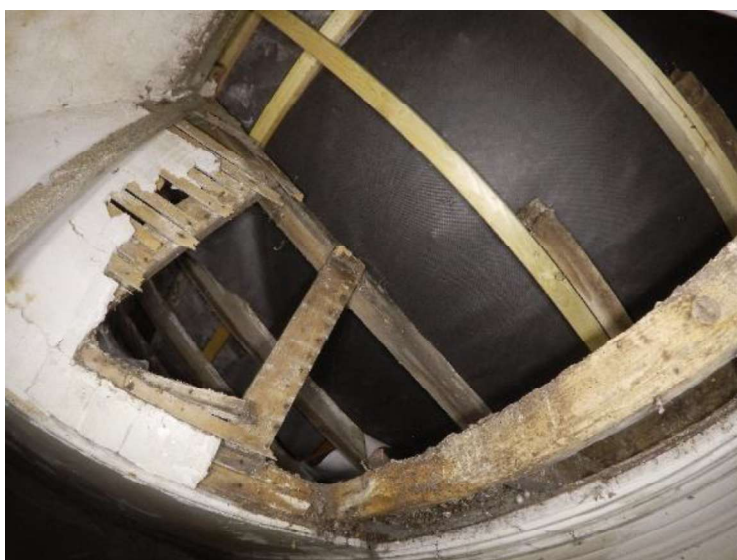
As mentioned in *section 6.1*, during our inspection of the main roof covering externally, we noted multiple areas of newer slates where repairs have been undertaken. We could establish from exposed areas internally that roofing underlay has been installed beneath sections of new slate, in order to provide an additional water-resistant barrier. It appears parts of the timber roof structure have also been replaced, as shown in *figure 27*. Whilst these repairs may be sufficient for a vacant building and have helped maintain the structural integrity of the roof thus far, there are still areas to the underside of the roof covering which are heavily decayed, and with no underlay installed, as shown in *figure 28*. Subsequently, we would advise that should the building be occupied in the future, the roof will require replacement in full.

Figure 27: Roofing underlay to main roof slope.

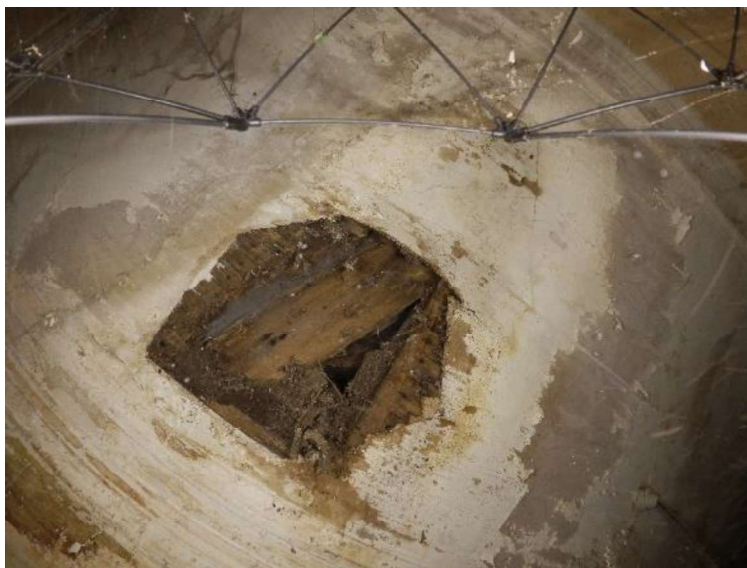
Figure 28: Slates exposed to underside of roof covering.

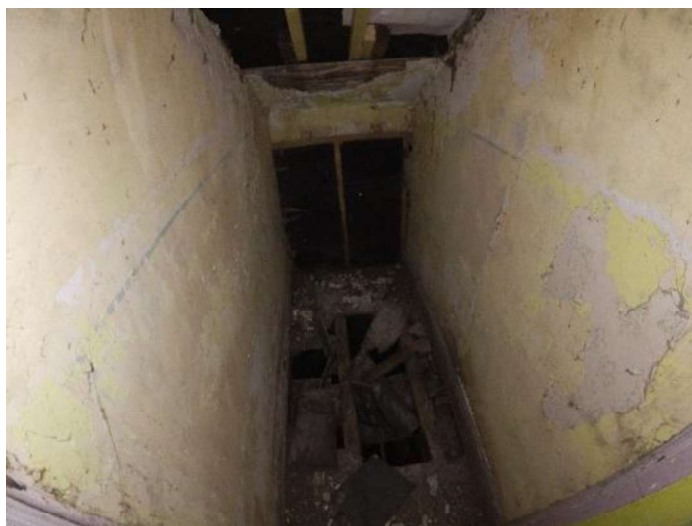
We noted the partial collapse of the timber floor structure to the second floor, likely as a result of rot to the structural timbers, as shown in *figure 29*. Due to the safety risk posed by rotten floor joists, we would advise that all floors are inspected for rot, and that affected timbers are to be cut out and replaced wherever necessary.

Figure 29: Timber floor joists exposed to second floor.

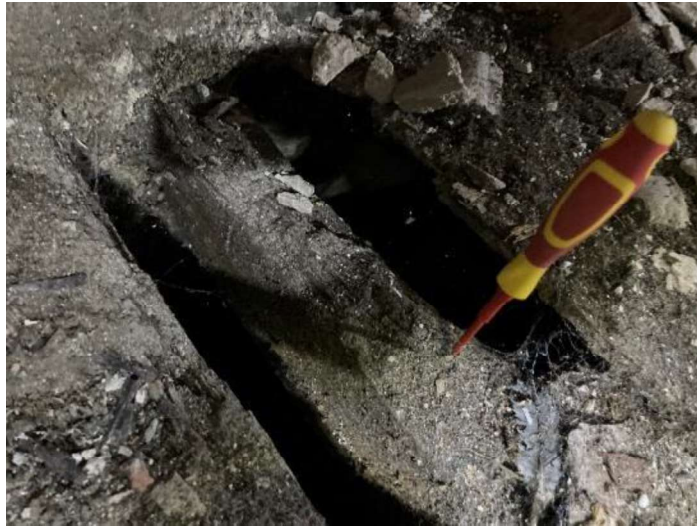
Areas in which timber floor joists were exposed showed visible signs of decay, and when probed showed extensive softening and timber decay (*figure 30*). We suspect roof leaks through the building (prior to recent roof repairs) to be the most likely cause of timber decay. Decayed sections of timber will need to be cut out and replaced, however if following further investigation rot is affecting multiple joists, complete replacement may be required.

Figure 30: Timber decay to ground floor timber floor joists.

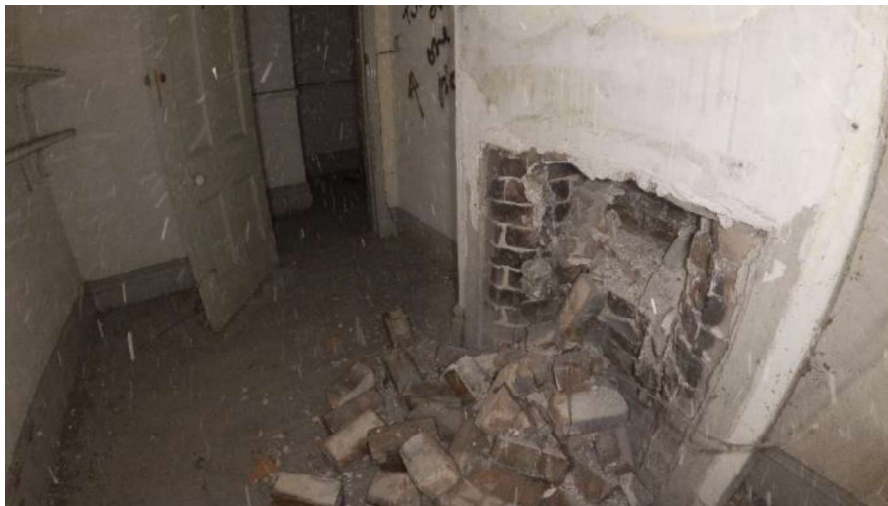
We noted the partial collapse of the brickwork chimney breast to the first floor, and the accumulation of excess rubble to the surrounding floor area.

Figure 31: Partial collapse of brickwork chimney breast to first floor.

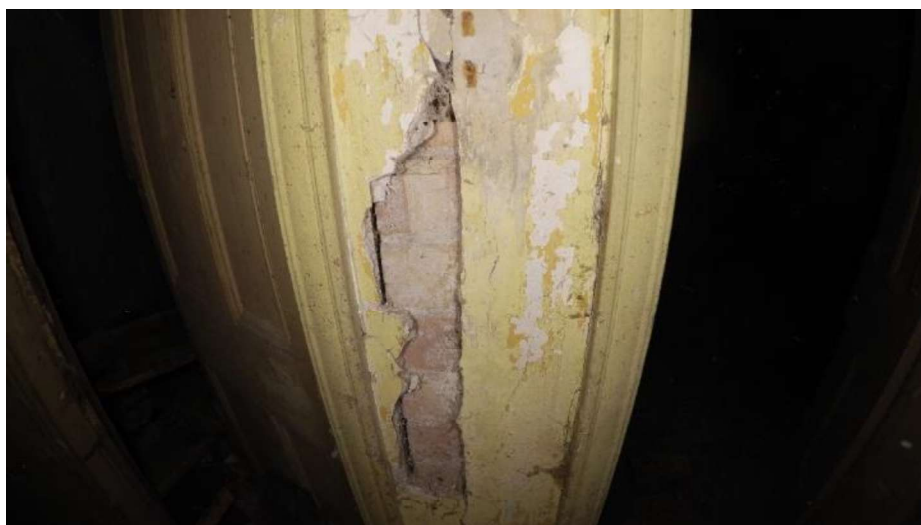
Plasterwork to walls is generally in poor condition, with cracking noted in various areas, exposing the masonry beneath.

Figure 32: Deterioration of plasterwork to second floor.

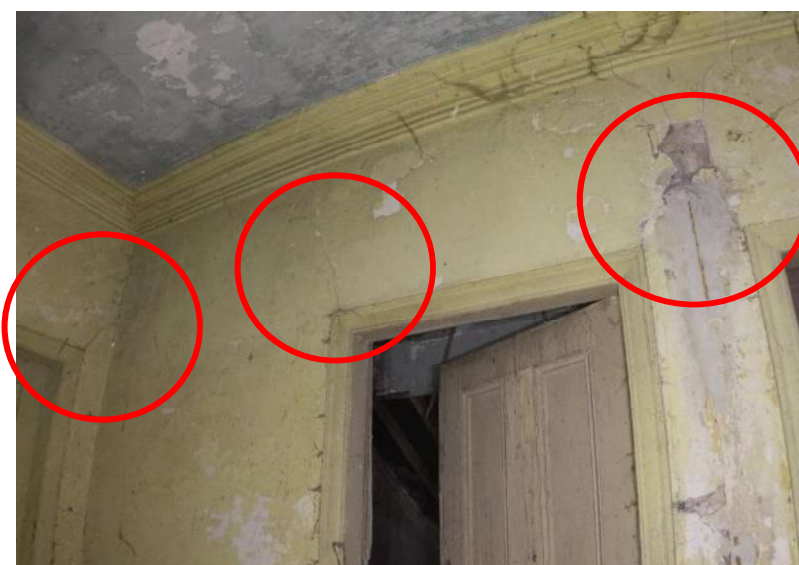
We noted cracking to plasterwork over structural openings, above door frames in particular, likely as a result of structural ground movement and timber lintel decay due to prolonged penetrating dampness. We would advise these areas will require opening up to conduct further investigation, and repair/replacement wherever necessary.

Figure 33: Cracking to plasterwork over openings on second floor.

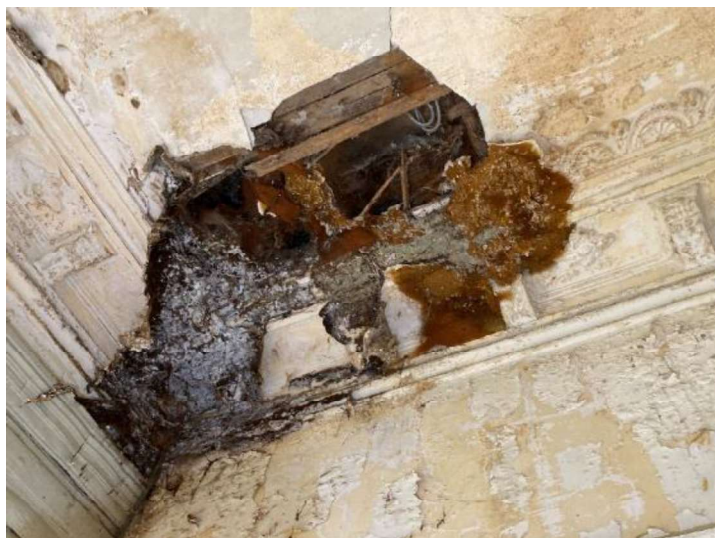
We identified dry rot to the ground floor ceiling, shown in *figure 34* likely caused by water ingress to the property, providing appropriate conditions for the infestation to propagate. Dry rot can compromise the structural integrity of a building, as the wood deteriorates over time, it can lead to sagging floors, collapsing roofs and in severe cases the structural failing of a building. Although dry rot predominantly affects structural timber, when left untreated, it can spread to other building materials. The dry rot would need to be treated

Figure 34: Dry rot noted to ground floor ceiling.

effectively by an industry specialist to avoid any further damage to the timber structure, ensuring the moisture source is removed, along with any other affected timbers to prevent recurrence.

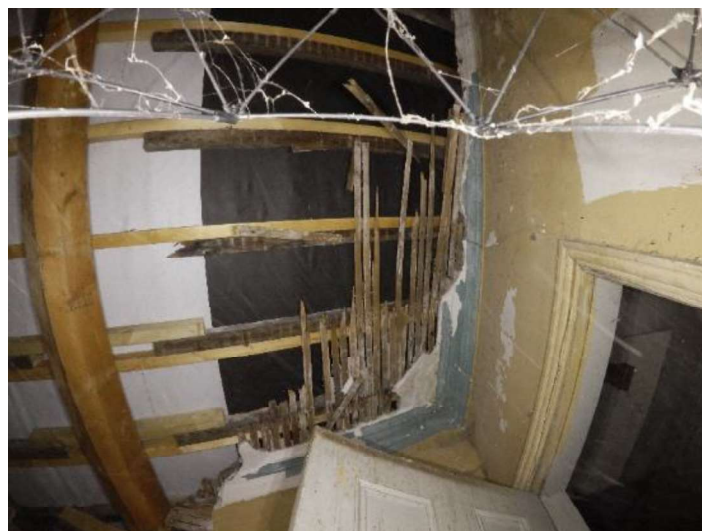
Figure 35 shows patch repair works conducted to the slate roof covering, with a breathable membrane installed as a secondary line of defence. Although these areas now appear watertight, pre-existing damage to the lath and plaster ceiling remains. We would advise all ceiling areas require opening up and investigating any structural roof timbers affected to be removed and replaced.

Figure 35: Patch repairs to natural slate roof covering visible from second floor ceiling.

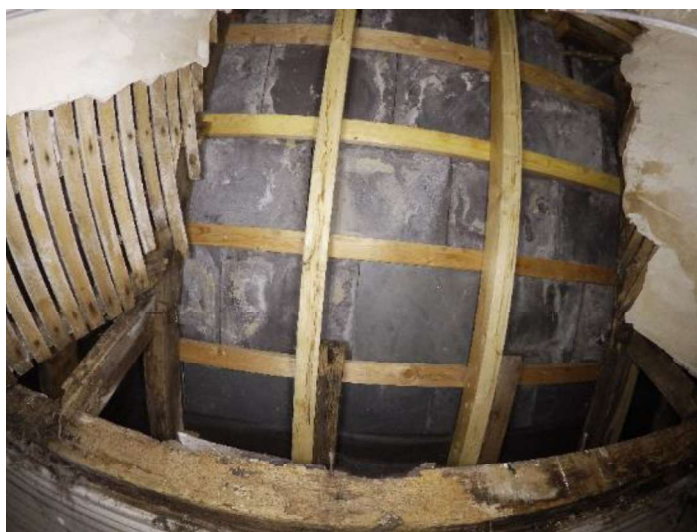
Although localised sections of the roof covering have received patched repaired, the original underside of the natural slate covering with lime torching remains visible original in various areas. This further confirms that full replacement of the roof covering is necessary, as well as the installation of a breathable membrane to the entire roof to keep the building watertight.

Figure 36: Original slate roof covering exposed to second floor.

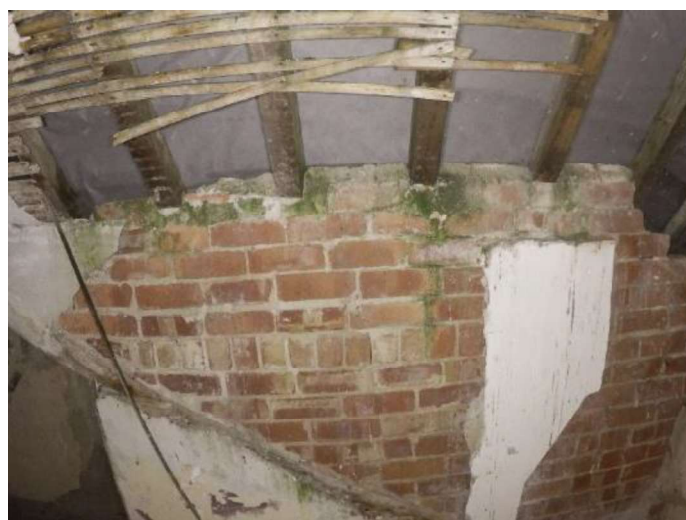
Extensive and prolonged penetrating dampness likely caused by water leaking through the previously failed roof covering has spread to internal masonry walls. As shown below in *figure 37*, algae growth can be seen to internal brickwork around wet timber rafters, suggesting moisture has been present for an extended period of time.

Figure 37: Penetrating damp to internal brickwork walls.

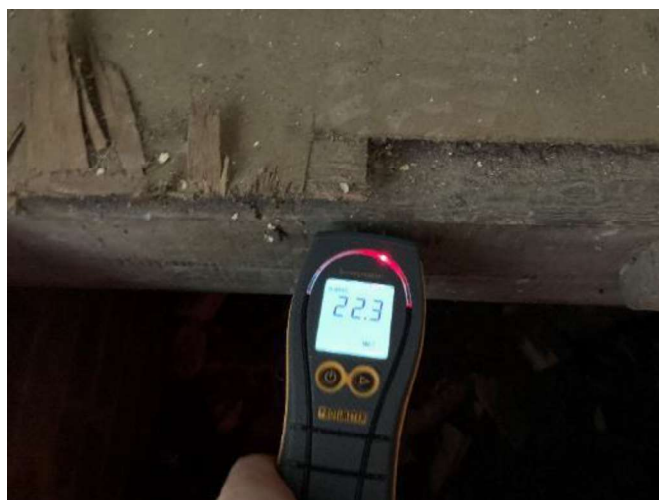
Deterioration of the floorboards has left the ground floor timber joists exposed, allowing us to take moisture readings from the timber using a Protimeter Moisture Meter. As shown below in *figure 38*, readings indicated high levels of moisture are present.

Figure 38: Moisture reading of ground floor timber floor joists.

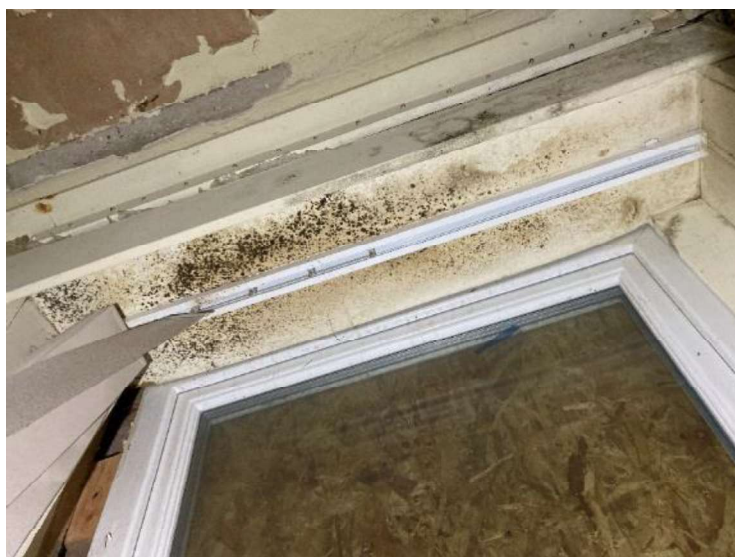
High levels of dampness and humidity in the property have led to the growth of black mould around window frames to the ground floor. As the property is vacant and disused, the lack of ventilation has likely caused the issue to worsen. As pro-longed exposure to black mould can pose potential health risks, we would advise specialist cleaning to remove.

Figure 39: Black mould noted around ground floor window frames.

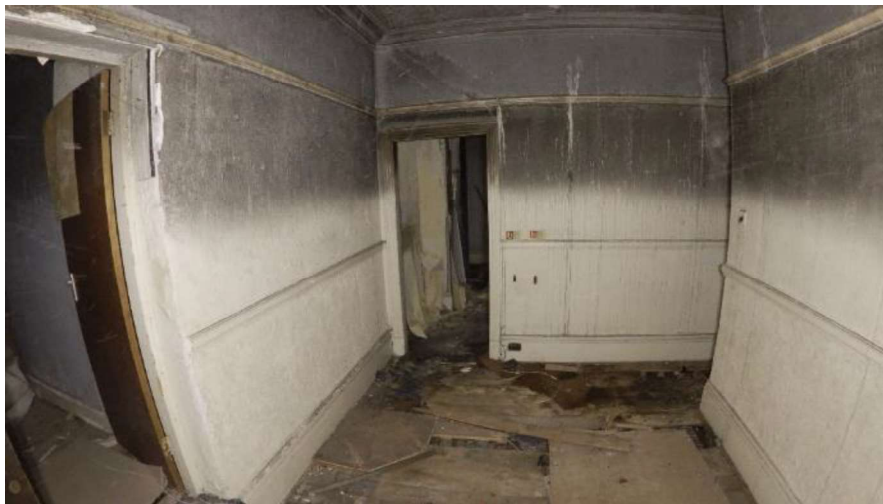
We noted extensive fire / smoke damage to the decorative linings on the walls around the building. All smoke damaged walls will require remedial works, including chemical cleaning to prevent the carbon deposits from the soot bleeding through any new decorative finishes. Soot also contains toxic particles

Figure 40: Fire / smoke damage noted to decorative linings of ground floor walls.

which can be inhaled when left untreated or improperly cleaned, so ensuring affected areas are cleaned thoroughly and effectively by industry specialists is imperative if the building is to be inhabited the future.
