**BUILDING CONDITION SURVEY
REPORT
TOAD HALL, SHORE ROAD,
AINSDALE,
PR8 2PZ
SEFTON COUNCIL
17th July 2024**

SEFTON COUNCIL

17th July 2024

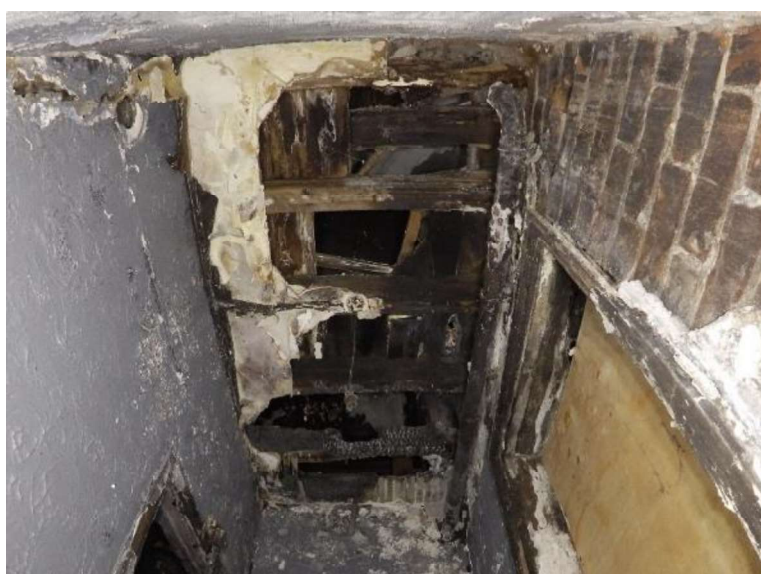
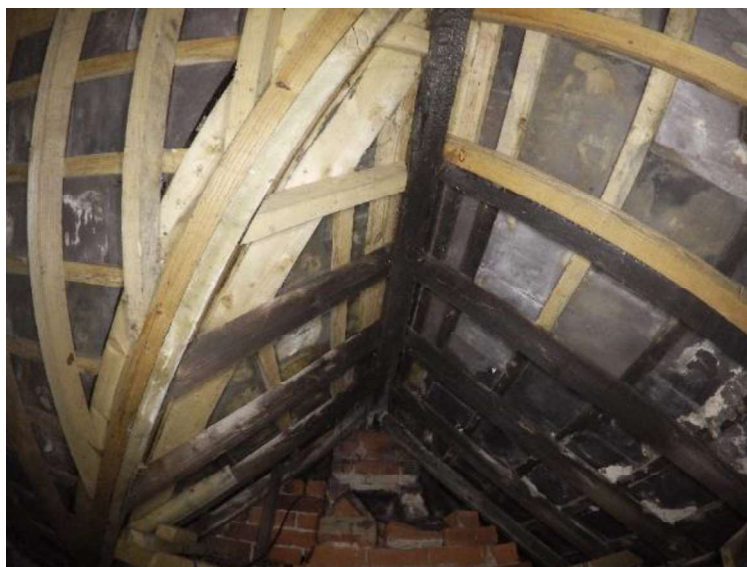
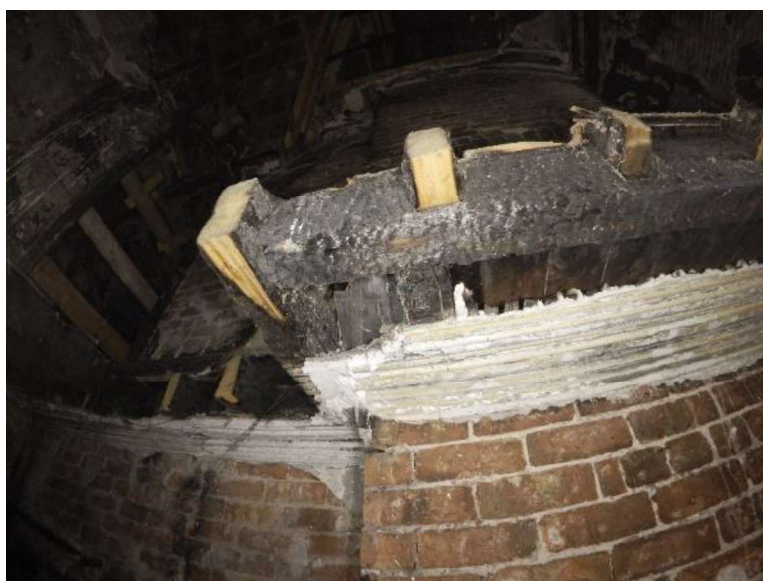
We noted extensive fire damage to the timber roof and floor structures. As shown in *figures 41, 42, 43* below, the fire has caused smoke / soot stains and charring of the timbers, to floor joists in particular. It appears remediation works have been attempted as a temporary fix to stabilise badly affected areas, such as cutting out of timber floor joists and installation of new rafters, however, these areas remain in a state of disrepair and require further replacement and remediation work to the timber structures ceiling if the building is to be restored into a habitable condition.

Figure 41: Fire damage to second floor timber floor structure.

Figure 42: Fire damage to timber roof structure, and localised patch repairs.

Figure 43: Fire damage to second floor timber floor structure, resulting in removal of timber joists.

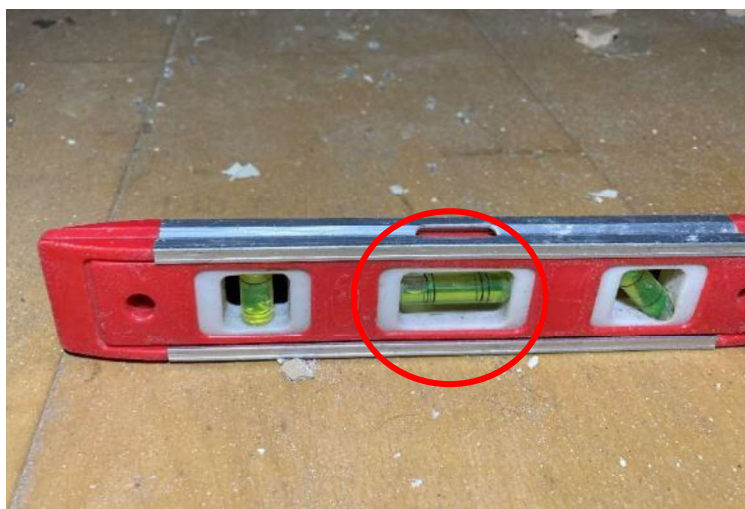
With the use of a spirit level, we were able to identify uneven / sloping floor surfaces to the ground floor of the building in particular to the front elevation that could signify structural movement. We were unable to conduct sub-floor checks during our inspection however given the number of other issues noted which signify ground movement to the building, we would suggest this is the likely cause.

Figure 44: Spirit level showing sloping floors to ground floor.

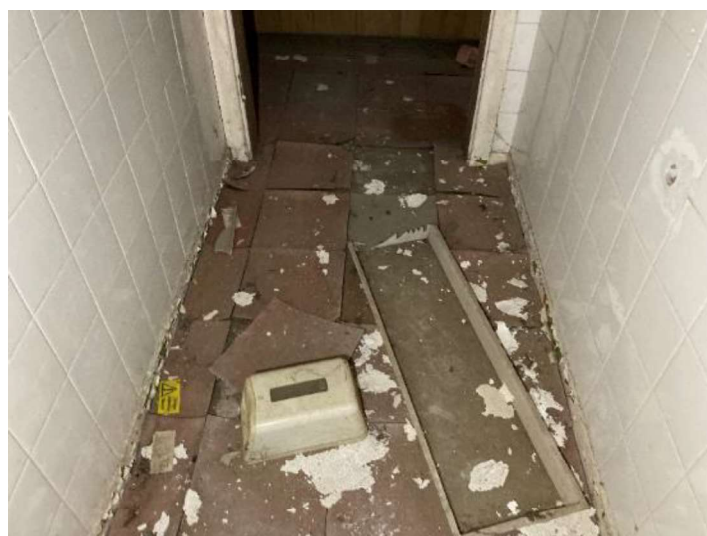
The tiled floor to the basement level bathroom was in poor condition with peeling vinyl floor tiles. Due to the high levels of damp identified in the property, we predict this has caused the deterioration of the floor covering, as moisture build up under the vinyl tiles can cause them to swell and delaminate. Strip off and replacement of the floor covering would be required, as well as further inspection of the floor structure below.

Figure 45: Bathroom floor covering to ground floor in poor condition.

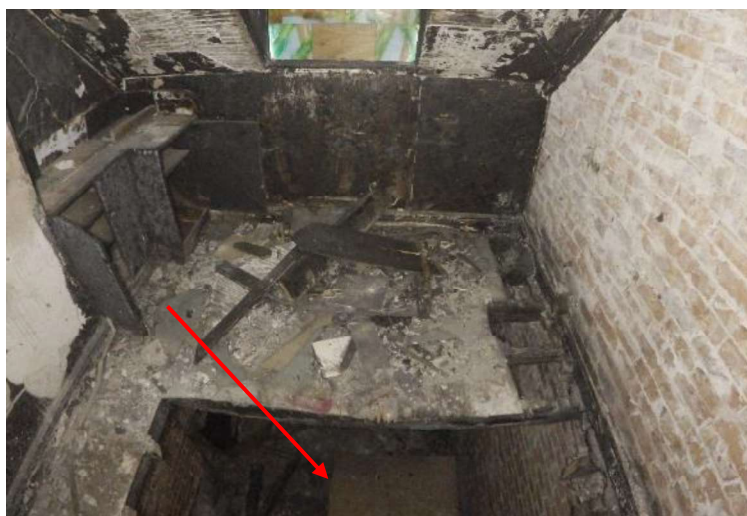
As mentioned in *section 7.3.2*, *figure 39* below shows the fire damaged timber floor section which has been removed. However, the remaining floor area appears to be sagging towards the centre of the joists and will also require replacing. Areas where the timber joists have been cut out are also still yet to be replaced, leaving a large void to the floor structure.

Figure 46: Fire damaged timber floor structure.

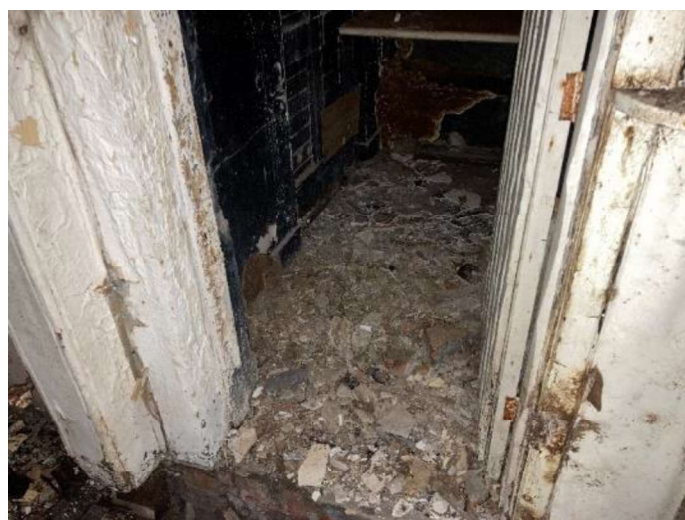
Internal doors are of timber construction and in a generally poor condition. As shown below in figure 47, timber to both doors and frames is showing signs of timber decay and metal hinges were heavily corroded. Internal doors are warped / swollen due to the high moisture levels in the property. We would subsequently conclude that internal timber doors are beyond repair.

Figure 47: Severe deterioration of internal timber door and frame, Building 3, ground floor.

We would advise full replacement of doors will be required. It should also be noted that during replacement works, it is likely that timber lintels may be suffering timber decay and may also require replacement.

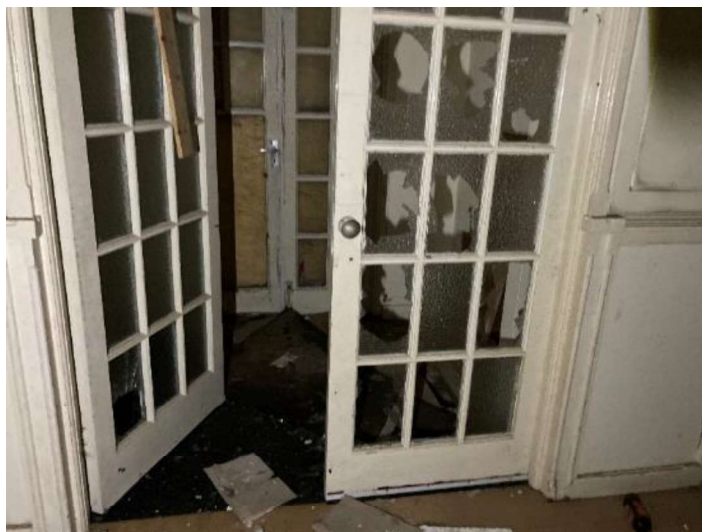
Doors with glazing panels were also in poor condition, as shown in figure 48 numerous panels were shattered, or glazing was missing and had been replaced with timber boarding.

Figure 48: Failure of glazing panels to timber doors, Building 3, ground floor.

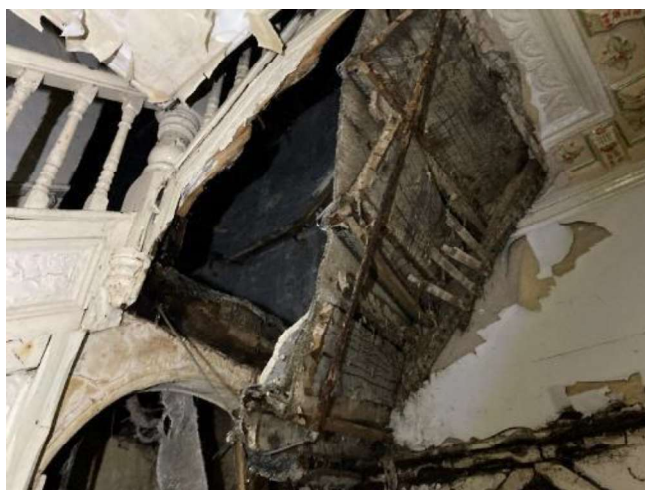
During our internal inspection of the ground floor, we noted that the ground floor staircase to building 4 has collapsed and is now hanging from the stairwell a result of fire and water damage. The entire staircase from ground to first floor will require replacing.

49: Collapse of soffit to underside of staircase noted to ground floor.

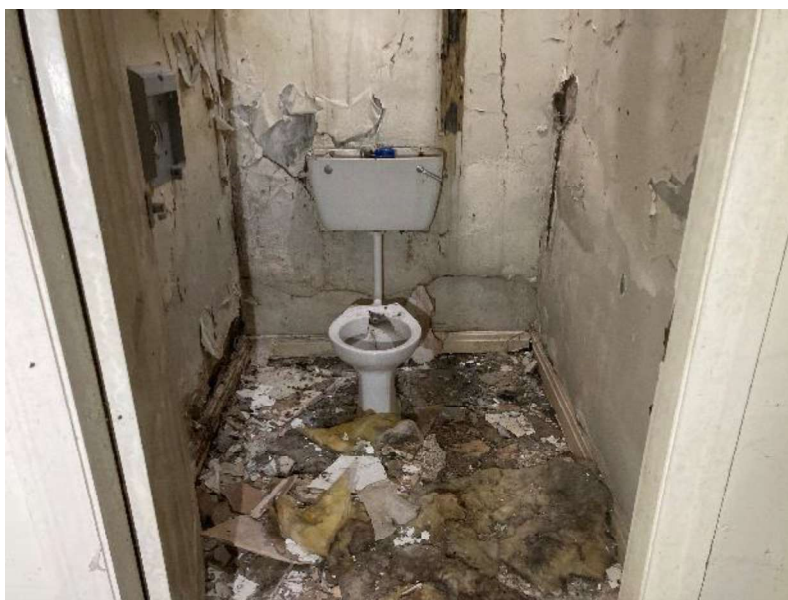
Generally all sanitary and kitchen fittings were noted to be either missing or in poor condition and would require replacement in all areas. See example to figure 50.

Figure 50: Sanitary fittings to building 3.

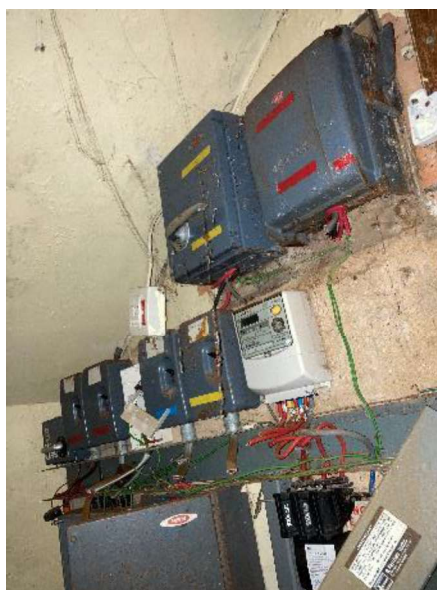
We have only undertaken a visual inspection of the areas we could gain access and would note that the electrical installation have been disconnected and would appear to be outdated (see figure 51) and likely the circuits will have suffered extensive water damaged beyond reasonable repair. We would expect any refurbishment proposals would require a complete rewire of the electrical installation to each of the 4 buildings.

Figure 51: Electrical equipment to building 4.

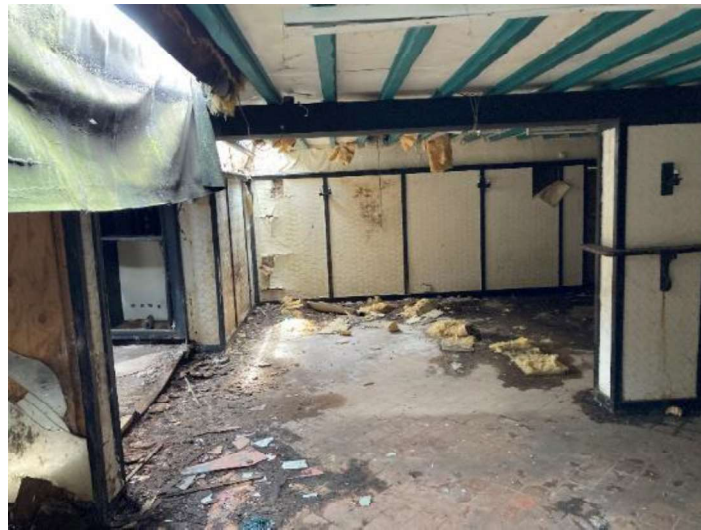
As shown in *figure 40*, most walls were concealed by linings or other decorative finishes. The peeling of the lining and the dark staining to certain areas indicates the presence of damp to the walls. We advise that the removal of linings / decorative finishes to the walls is necessary to further examine the condition of the masonry beneath.

Figure 52: Stained / peeling decorative linings noted to walls.

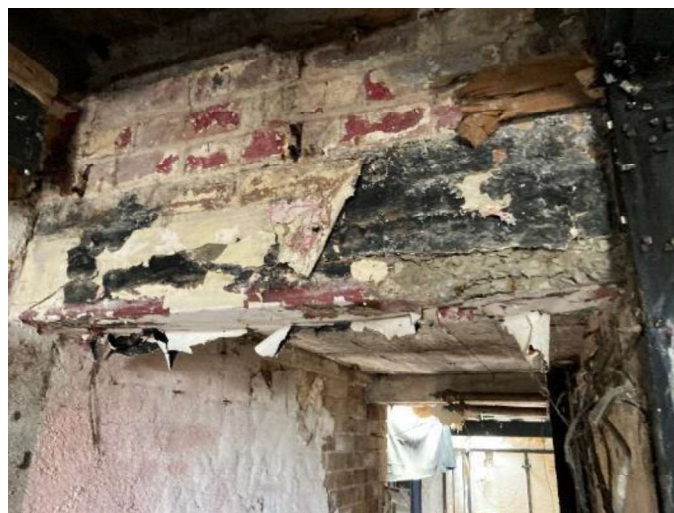
We noted deflection, cracking and spalling to the internal concrete lintels with corrosion to the steel reinforcement causing cracking to surrounding brickwork.

Figure 53: Failure of lintel.

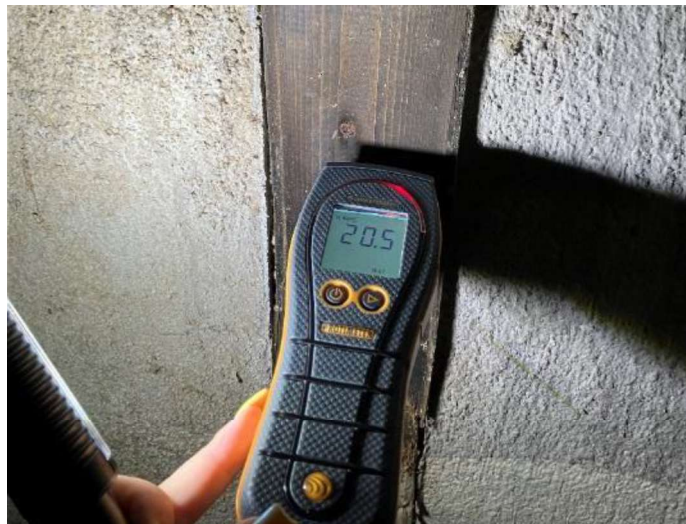
The internal finish followed a mock Tudor style aesthetic, with exposed mock timber framing to most internal walls. As shown in *figure 54*, we took a moisture reading of the timbers with a Protimeter, which returned high readings indicating internal dampness and increased risk of timber decay.

Figure 54: Moisture reading of exposed timbers to internal walls.

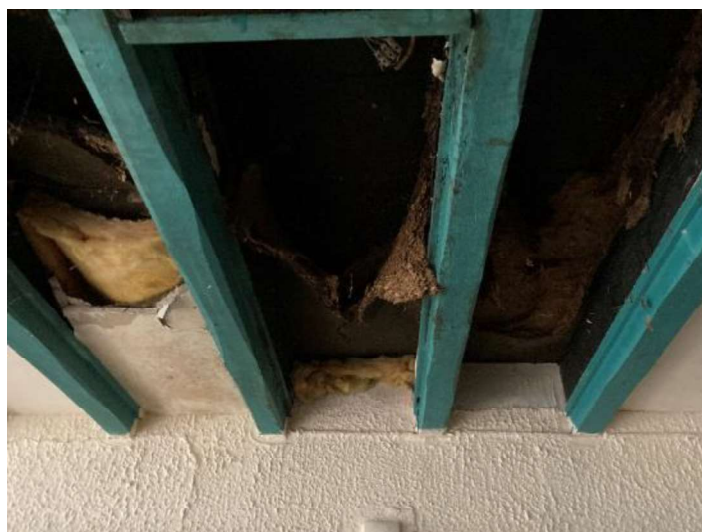
The flat roof has been configured as a cold roof with loose quilt insulation noted internally below the deck. This configuration is no longer recommended and flat roofs and replacement roof covering works would require rigid insulation over the deck in a warm roof configuration. The deterioration of the ceiling soffit in some areas has left the flat roof materials exposed, with the chipboard visibly wet and sagging, and the insulation readily exposed. Following inspection of the roof externally, it is likely the insulation is already saturated with rainwater due to the poor condition of the covering and we would subsequently advise the flat roof needs to be removed and re-constructed.

Figure 55: Failure of flat roofing materials.

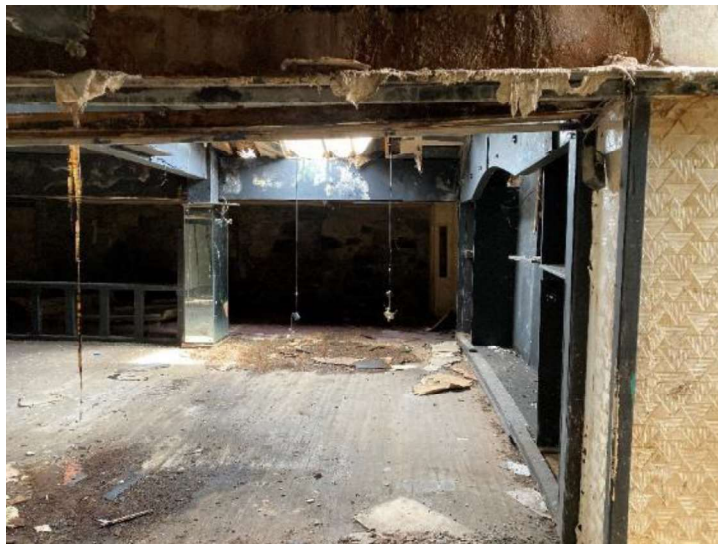
The area shown below in *figure 56* was inaccessible due to the unsafe nature of the roof covering. However, we noted daylight entering the property, confirming the partial collapse of the roof, which will allow rain to penetrate into the building.

Figure 56: Daylight noted through hole in the roof.

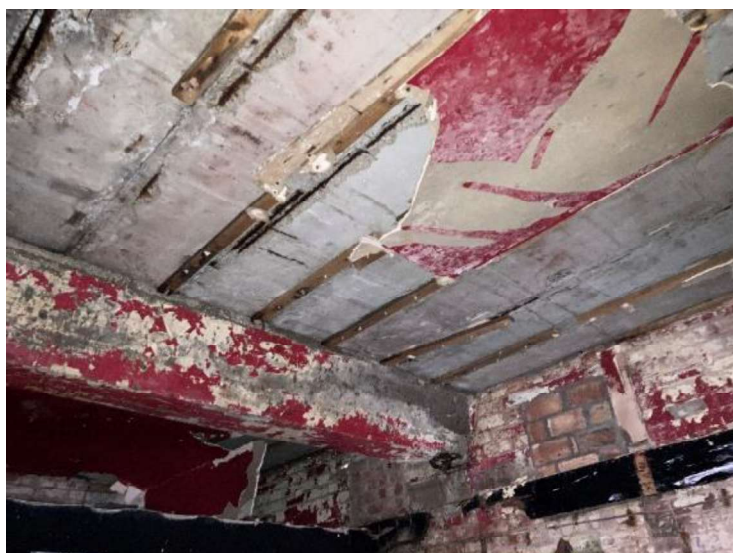
Some areas were configured with concrete ceiling soffits with a plasterboard finish, however as shown in *figure 57*, the plasterboard was heavily deteriorated, leaving the concrete exposed in most areas. This allowed us to identify dampness, cracking and spalling to the concrete soffits, as well as exposed corroded steel reinforcement bars. We would advise that any steel reinforcement bars that are heavily corroded. Replacement of the roof structure is likely to be more practical than extensive repairs.

Figure 57: Corrosion of concrete exposing corroded steel reinforcement bars.

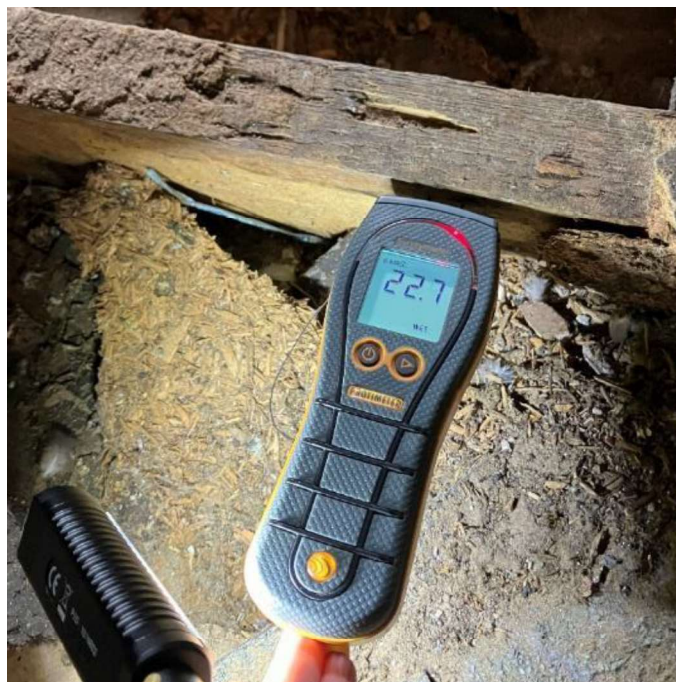
The open plan area is stepped at different level with a variety of suspended timber and solid concrete ground floor construction. We noted timber decay to the timber floor structures, with moisture metre readings indicating high levels of moisture in the timber, shown in *figure 58*. Due to the failure of the flat roof structure, it is likely that extensive and pro-longed roof leaks are likely to have resulted in timber decay to the timber floor structure and saturation of the concrete floor slabs.

Figure 58: Moisture metre reading of timber floor joists.

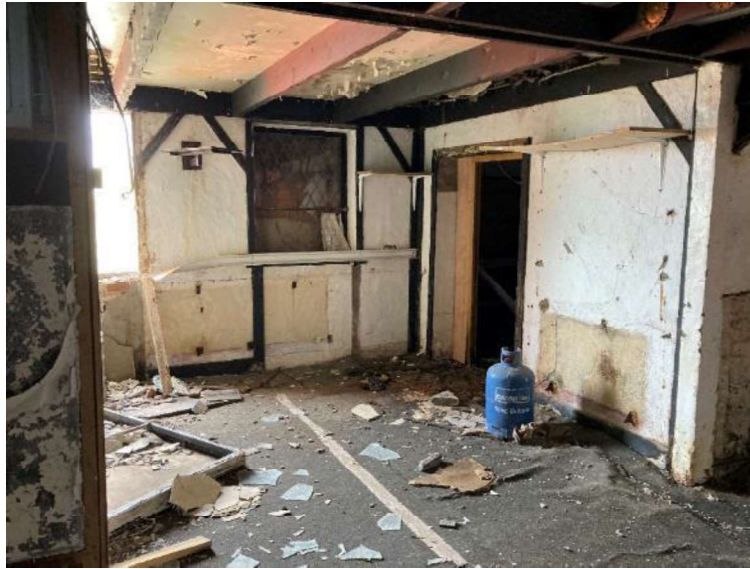
Although some floor areas were concealed by carpet, the poor condition of the floor beneath was still apparent. Areas which were covered with carpet were significantly wet to the touch, leading us to assume the timber floor structures have suffered water damage. As shown in *figure 59*, the floor is also uneven in areas, and we noted movement to the timber suspended floor when walking on certain sections. Due to the extent of water damage and dampness we expect the ground floor structures have suffered extensive water damage would likely require replacing in full and insulating to meet current Building Regulation.

Figure 59: Uneven floor surfaces.

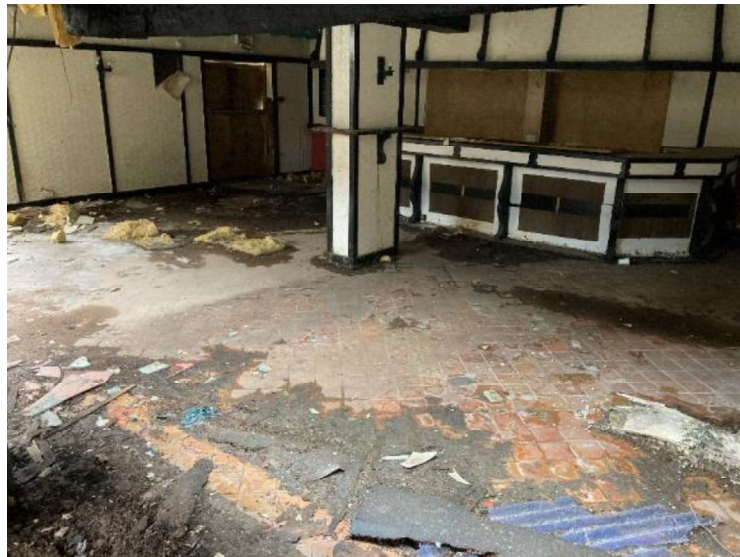
Following the failure of the roof covering there is an accumulation of roofing materials gathered on the floor i.e. insulation, felt, plasterboard, in areas where the roof has suffered partial collapse, further confirming its dilapidated state.

Figure 60: Accumulation of roofing materials on floor.
