Flood Investigation Report

Fouracres (Maghull), Sefton Lane (Maghull),
Hawksworth Drive (Formby), Water, Street (Thornton)
and Moss Lane (Lydiate)

Date of flooding: 24/09/2012

Version 1.2
November 2012

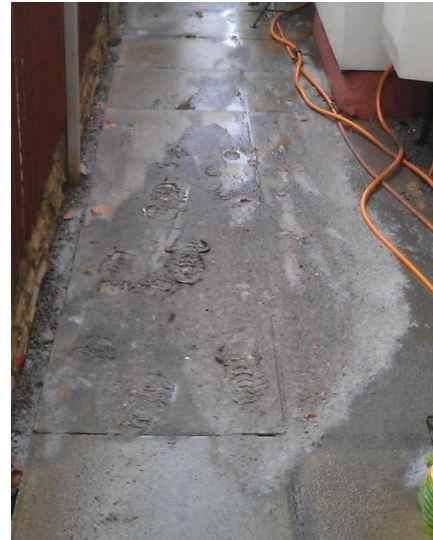
Figure 5: Foul debris residence side passage

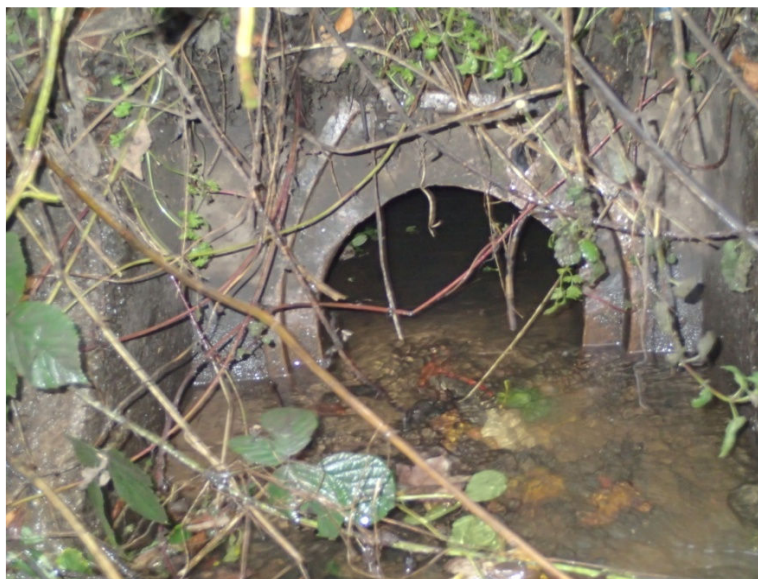
United Utilities did not find a blockage on the surface water sewer system either. However, it was found that neither of the 2 outfalls which discharged into Dover's and Whinny Brook had a flap/non return valve on them. They have undertaken to carry out further investigations on the system to better understand it and check for cross-connections.

Below is a picture of the outfall from Fouracres into Whinny Brook which was taken during a period of low flow, the outfall is still partially submerged.

Figure 8: Outfall from Fouracres into Whinny Brook, taken 06/11/2012

Number	Recommendation	Lead Risk Management Authority
1	Investigate the merit of installing flap valves/non return systems on the outfalls into Whinny Brook and Dover's Brook.	United Utilities
2	Co-ordination of maintenance priorities and works between the Risk Management Authorities	Environment Agency
3	Work with landowners with riparian duties to reduce the impact of debris and blockages.	Environment Agency
4	The Council should work more closely with the Canal and River Trust in order to understand the role and potential contribution of their systems to flood risk	Sefton MBC
5	The Council, Environment Agency and United Utilities need to review how they share intelligence and co-ordinate responsibilities	Sefton MBC
6	The risk management authorities should review other locations where this mechanism for flooding might be an issue	United Utilities

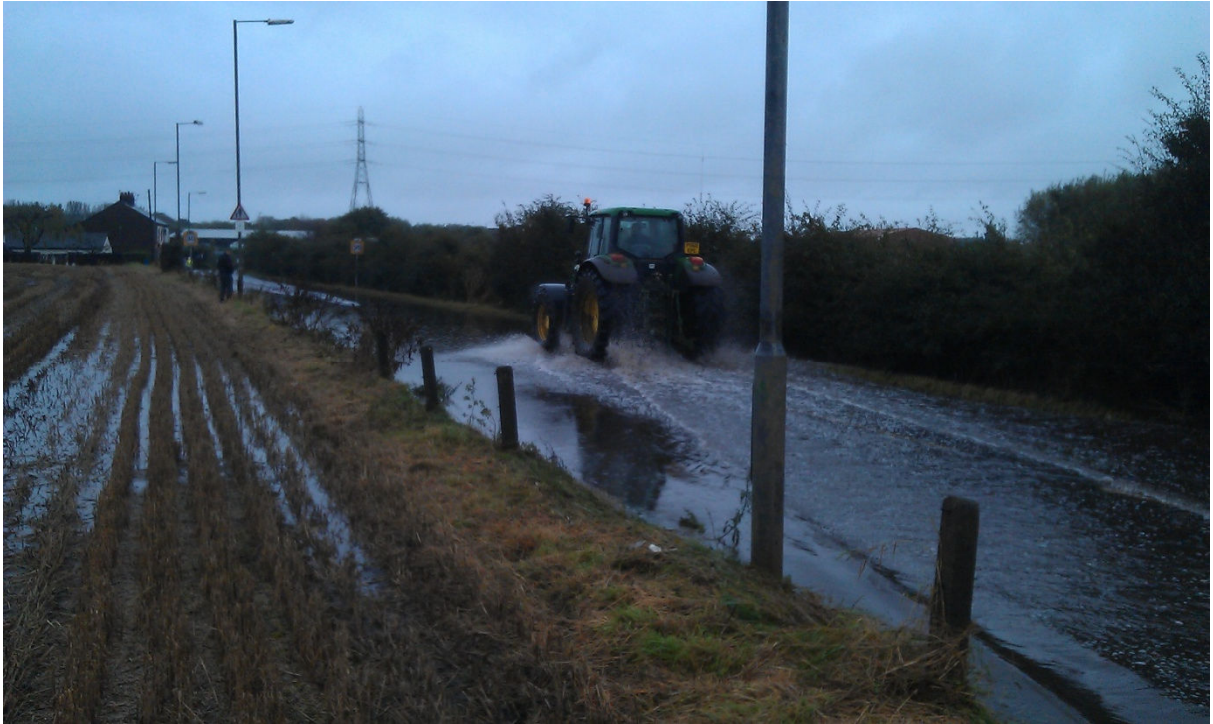
The second stretch (B, Figure 13 and figure 14), of highway flooding was between the bridges over the River Alt and Dover's Brook to a depth of approximately 15 cms.

Figure 13: Bridges Lane, area B, taken 25/09/2012

Figure 14: Bridges Lane, area B, taken 25/09/2012

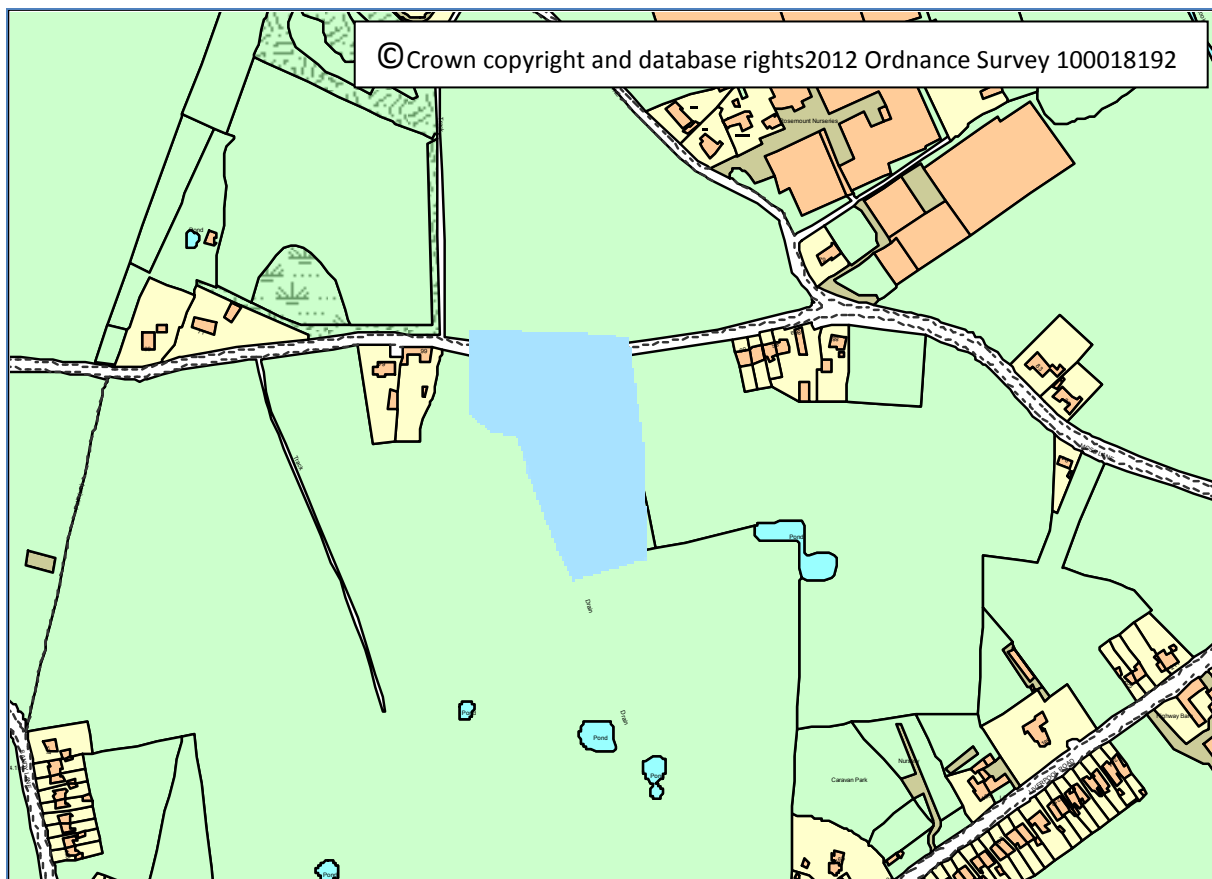
The capacity of the culvert which the watercourse flows into was not sufficient to handle the flow during this event. The watercourse serving the agricultural land at the rear of the even numbered properties in Moss lane connects to this culvert near to 68 Moss Lane. This culvert is inadequate for flows of this magnitude and this leads to flooding as storm water backs up and overflows the banks of the open ditch affecting the farmed fields, residential properties and the highway.

Moss Lane is served by a 150mm and a 225mm culvert that connects into the 450mm diameter pipe at the junction with the A59-North Road. It is not known if the culvert capacity was ever sufficient for these types of flows or whether something has changed upstream to affect the rate of discharge from the land.

Figure 24: map showing the approximate flood envelope

Number	Recommendation	Lead Risk Management Authority
1	Discuss the issues with the riparian land owners and seek to negotiate a solution	Sefton MBC
