GUIDE FOR THE
MAINTENANCE
AND REPAIR
— OF —
LORD STREET'S
VERANDAHS

Introduction

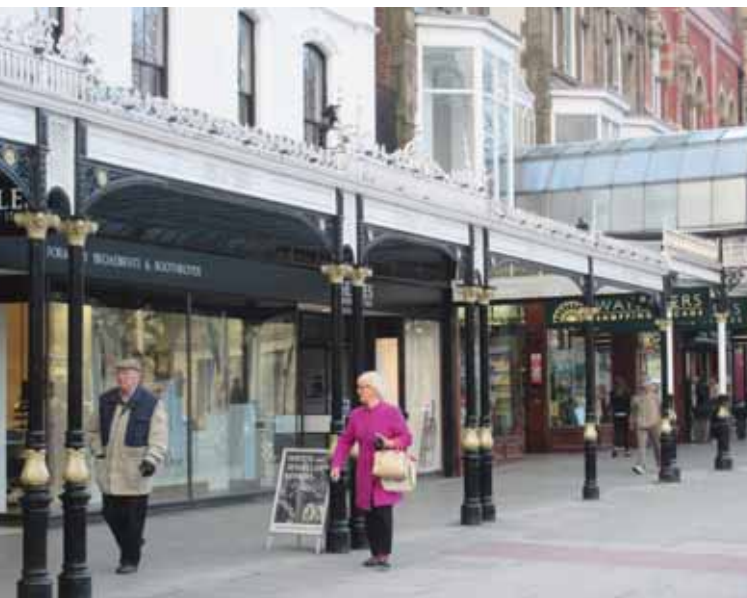
Early verandahs include supporting columns beneath spandrel brackets and an ornamental frieze.

The verandahs fall broadly into two types. The earlier verandahs have supporting columns and were designed with similar scale features, but varying decorative treatments. Columns comprise a base, column and capital, and are flanked by decorative spandrel brackets supporting a frieze (see explanatory drawing on page 8). Roofs entail narrow glazing bars running perpendicular to the building, glazed with Georgian wired glass.

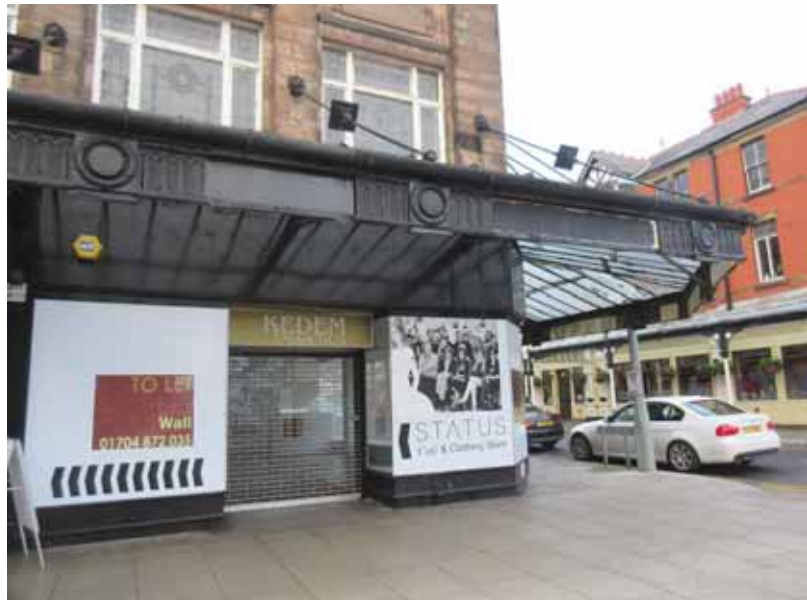
In later 20th century designs, a novel cantilevered approach was sometimes preferred and offers an unusual but attractive alternative to verandah design.

Later canopies on buildings from the early 20th century often used a cantilevered style of construction. Examples of this can be seen at the junctions of Lord Street with Coronation Walk and Bold Street, where verandahs are free of supporting columns.

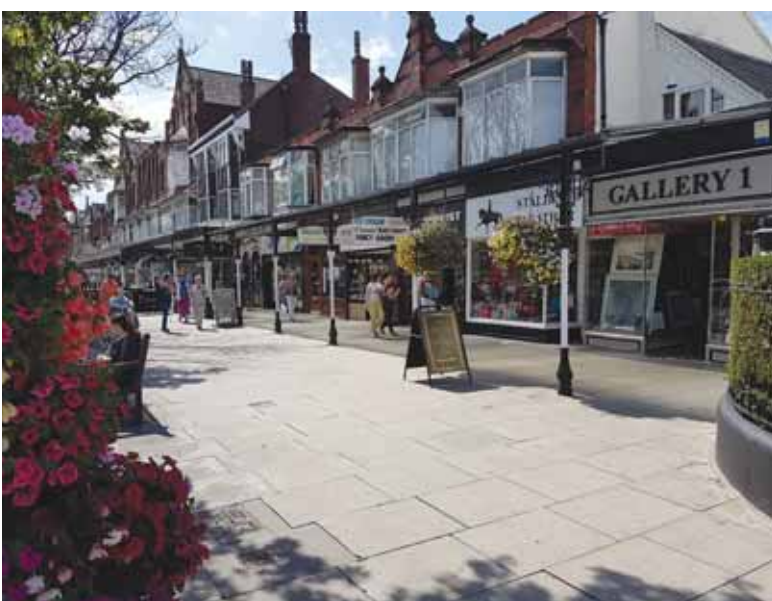
Despite their unique and individual details, Southport's verandahs remain largely similar in size and form.

Verandahs were created by qualified architects with a flair for design, and as a result can be quite elaborate and decorative. Each installation is constructed and ornamented differently, though generally they are built to relatively consistent dimensions and features. Some incorporate 'rainwater goods' within columns, others have curved glass roofs and some incorporate space for a fascia. Overall they have a strong unity of appearance and scale.

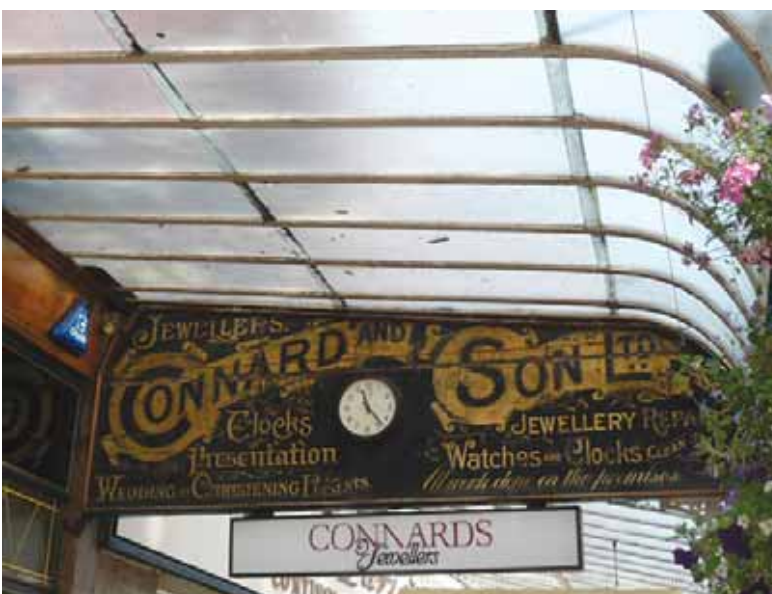
Historic advertisements add vitality and enhance the visual appeal of Southport, as well as promoting the town's commercial heritage.

A number of verandahs in Southport retain highly important historic signage which must be conserved. These panels advertised businesses that once operated from the property and are usually constructed of timber. Flaking elements of paint should be reapplied in a like-for-like manner using appropriate timber paint. Sections of damage or decay should be repaired using specialist methods and materials. Historic signs contribute to the vitality of the conservation area and are unique components in Southport's shopfronts. Contact Sefton Council before embarking on any repair work for further advice and guidance.

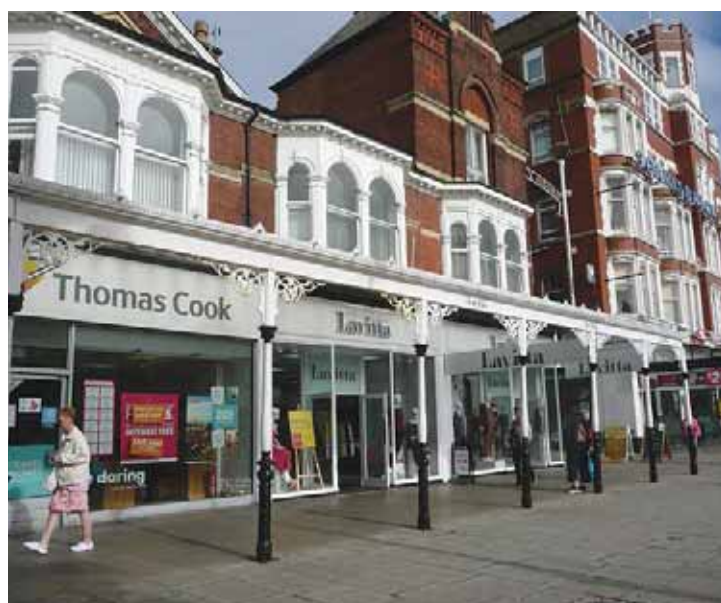
The verandahs of Lord Street benefit from a highly regimented colour scheme bringing a sense of unity and cohesive character to the locality.

The black and white colour scheme which has been adopted for virtually all the verandahs is highly practical in the sense that it is easy for neighbouring verandahs to be painted to match, despite varying ownerships. This consistency in the colour scheme enhances their character and sense of unity. To maintain the special character of the Lord Street Conservation Area, it is important that this scheme is maintained.

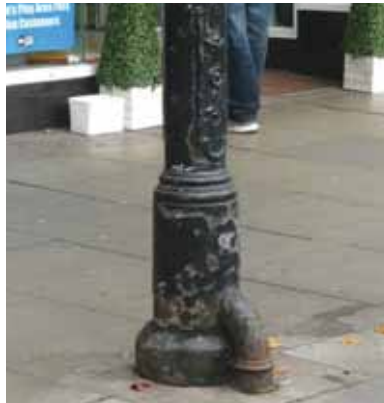
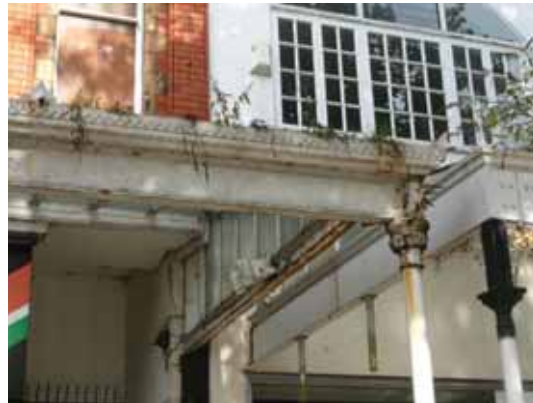
Blocked gutters quickly leads to an overflow of rainwater. Gutters should be kept free of debris and all downspouts should allow for an unobstructed flow of water from above.

Blocked gutters

Blocked gutters prevent rainwater from running free of the verandah, and will quickly cause problems. A small but regular investment in gutter clearance will limit the need for extensive and expensive repairs later. Blockages will inevitably lead to an overflow of rainwater and unsightly areas of rust and decay, not only on the guttering itself, but also the cast iron columns which support it.

Regular inspections to ensure that all gutters are free of residue should be carried out and any deposits should be immediately removed. This will allow for an unobstructed flow of rainwater and significantly reduce the risk of more serious problems in the future. If your verandah features hollow columns, be sure to flush out any accumulation from within. A verandah's ability to discharge rainwater is crucial to maintaining the overall condition of the verandah and shopfront.

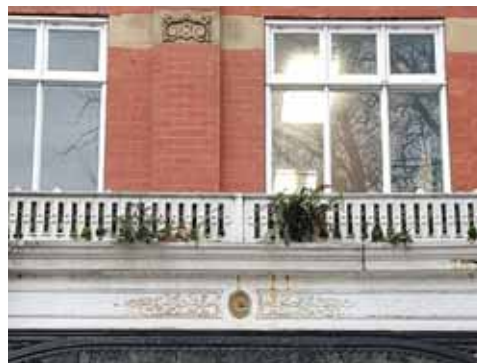
Problems such as plant growth suggests a lack of care of attention, not only to the verandah but to the premises as a whole. It can also result in other complications including rust and staining.

Similar to organic residue, active plant growth presents a clear risk of blockage and will only worsen if left untreated. Plant growth can often be seen from the street level and can make even the smartest of shopfronts appear untidy. Consistent and regular maintenance will reduce the ability of plants to take root. Plant growth may also be found in the iron work itself, particularly in and around the joints. Such growth should be carefully removed at the first opportunity to prevent water ingress and further risk of decay.

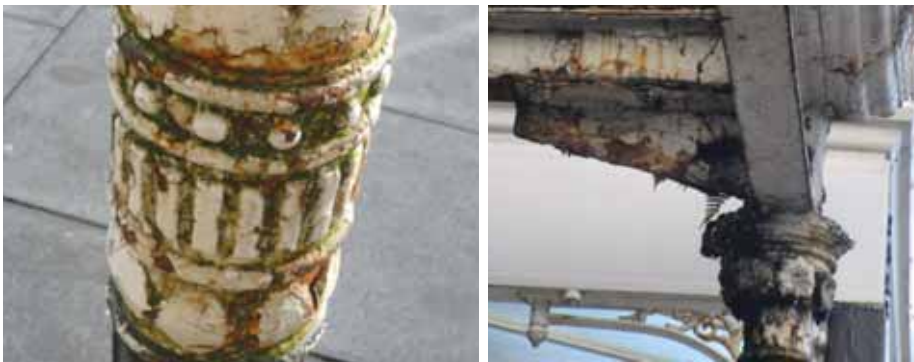
The structural form of a verandah can be a problem in itself. Where water traps occur, ensure these points are maintained exceptionally well and if possible rectified in an appropriate manner.

Water traps in the decorative verandah ironwork can prove distinctly problematic as corrosion tends to occur more frequently at these points. Water traps can also be caused by unsealed joints and holes, the accumulation of dirt, and where corrosion has previously developed. These problems should be appropriately addressed with the minimum levels of intervention.

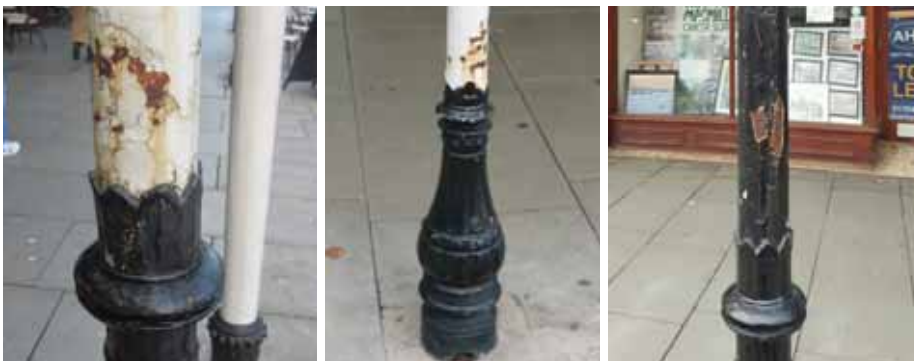
Localised corrosion looks unpleasant and can be an indicator of problems beneath the paint. Such instances require swift attention to prevent prolonged decay.

An uneven surface on ironwork (also known as pitting) is a form of localised corrosion that not only looks unattractive, but is also an indicator of hidden dangers. This occurs on ironwork that has been previously painted and often provides evidence that the surface of the iron is corroding beneath the paint. This kind of corrosion is highly detrimental as it causes little loss of material with the small effect on its surface, while damaging the deep structures of the metal. A noticeably oily surface on the surface may provide further clues as to this problem.

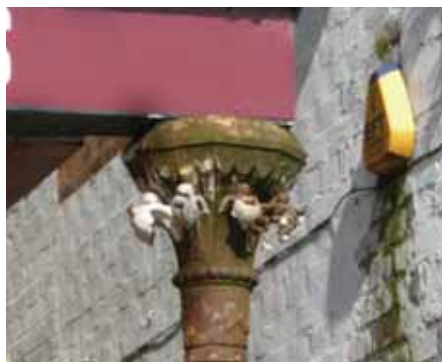
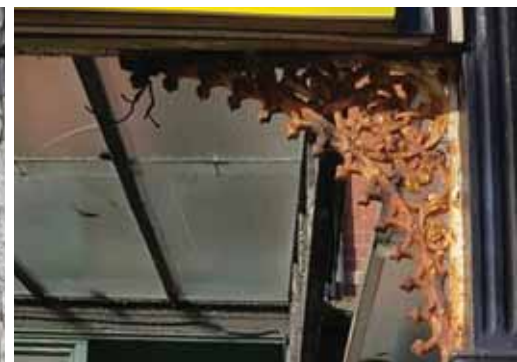
If left untreated rust can lead to fractures in the iron work and threaten the entire stability of the verandah and its various components.

Iron corrodes and delaminates as it expands, and the process can distort the design and composition of the ironwork by forcing its various elements apart. Iron may break under stress without warning, so it is important to rectify any instances of corrosion as soon as possible. Areas of corrosion should be removed as soon as they are detected by hand, using a wire brush, chisel and sandpaper. Do not sand-blast as this can result in a loss of historic detail and fabric. Bare metal should not be left exposed due to the high risk of further decay. If in a reasonable condition, metal should be repainted in an appropriate paint following the manufacturer's instructions without delay.

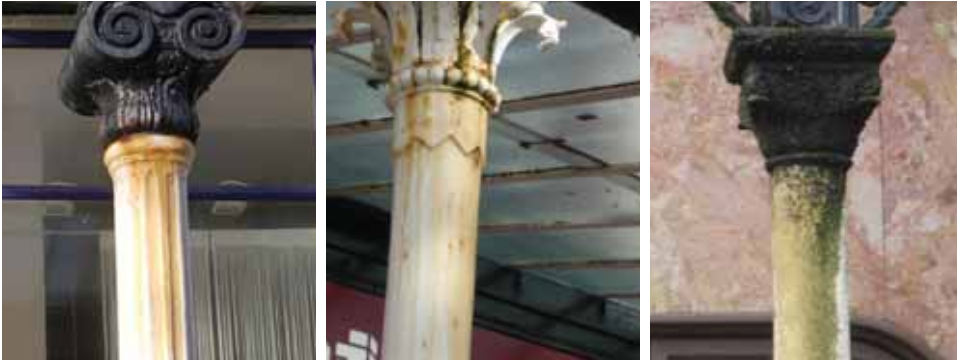
Staining is often a symptom of rust or decay elsewhere on the verandah. The source of the problem should be tackled and the affected section returned to its original appearance.

Discolouration most often occurs when rust has washed over painted ironwork, particularly where it has been painted in lighter shades. The source of the rust should be identified and treated. Only then should the affected areas be cleaned and if necessary, repainted in a matching colour with appropriate metal paint.

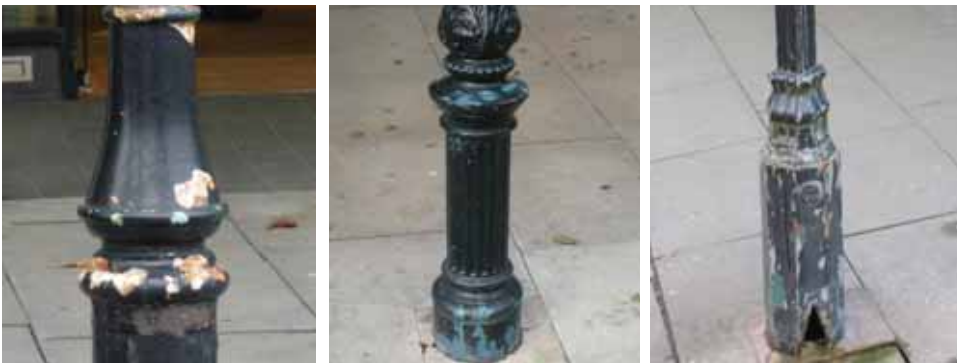
Flaking paint has the potential to hold moisture and encourages the formation of rust. New paint should be applied at the first sign of decay.

Flaking or brittle paint is not only unattractive, it also poses a serious threat. Paint in a poor condition can trap and hold moisture, preventing ironwork from drying out and leading to corrosion. A new coat will be required.

Be sure to clean away any flaking paintwork before applying a new matching coat. It is important to remember any paint system applied will only be as good as the surface beneath. This can be achieved using a chisel, wire brush heads fitted to power tools or simple wire wool. A failure to clean and prepare metal surfaces properly before painting is a key cause of deterioration and corrosion.

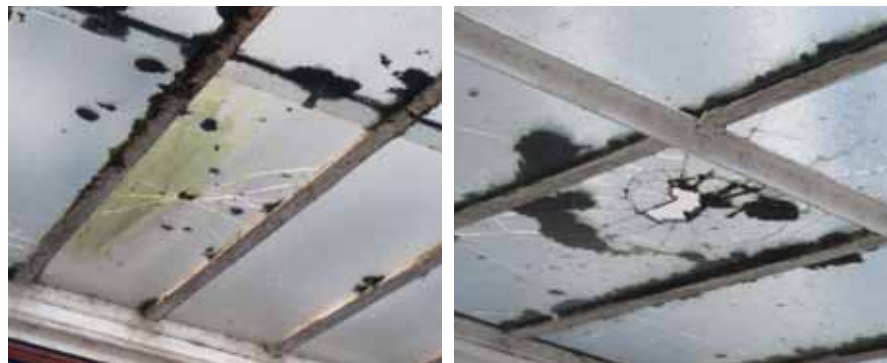
Cracked glazing is as dangerous as it is ugly. Broken glazing panels should be replaced in a like-for-like design and kept free of growth and debris.

Due to their delicate composition, verandah glazing panels can crack over time through general wear and tear. Regular inspections of panels should be carried out in order to ensure their good condition, being free of debris, and that they do not present a danger. Fallen masonry, timber, branches and pigeon droppings can all inflict damage, or cause glazing to become unattractive. If repairs are necessary like-for-like Georgian glazing replacements are required to respect the architectural significance.
