Flood Investigation Report

Fouracres (Maghull), Sefton Lane (Maghull),
Hawksworth Drive (Formby), Water, Street (Thornton)
and Moss Lane (Lydiate)

Date of flooding: 24/09/2012

Version 1.2
November 2012

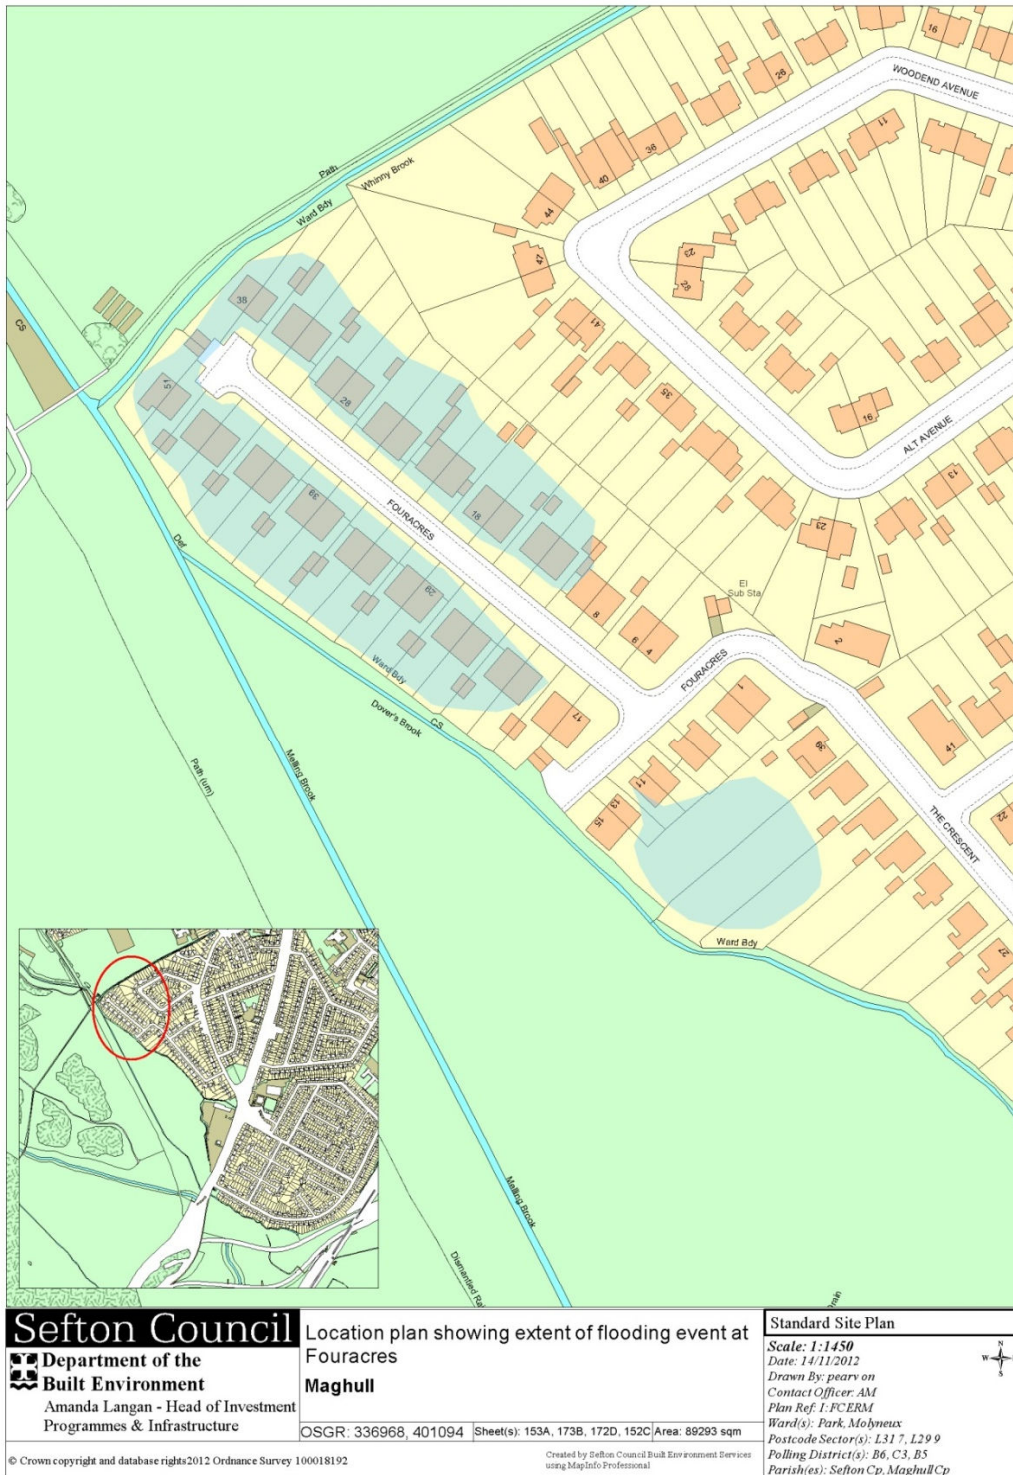
Figure 1: Site location and flood extent

Fouracres is a small residential cul-de-sac situated at the confluence of Whinny Brook and Dover's Brook on the western side of Maghull. The estate was built circa 1964.

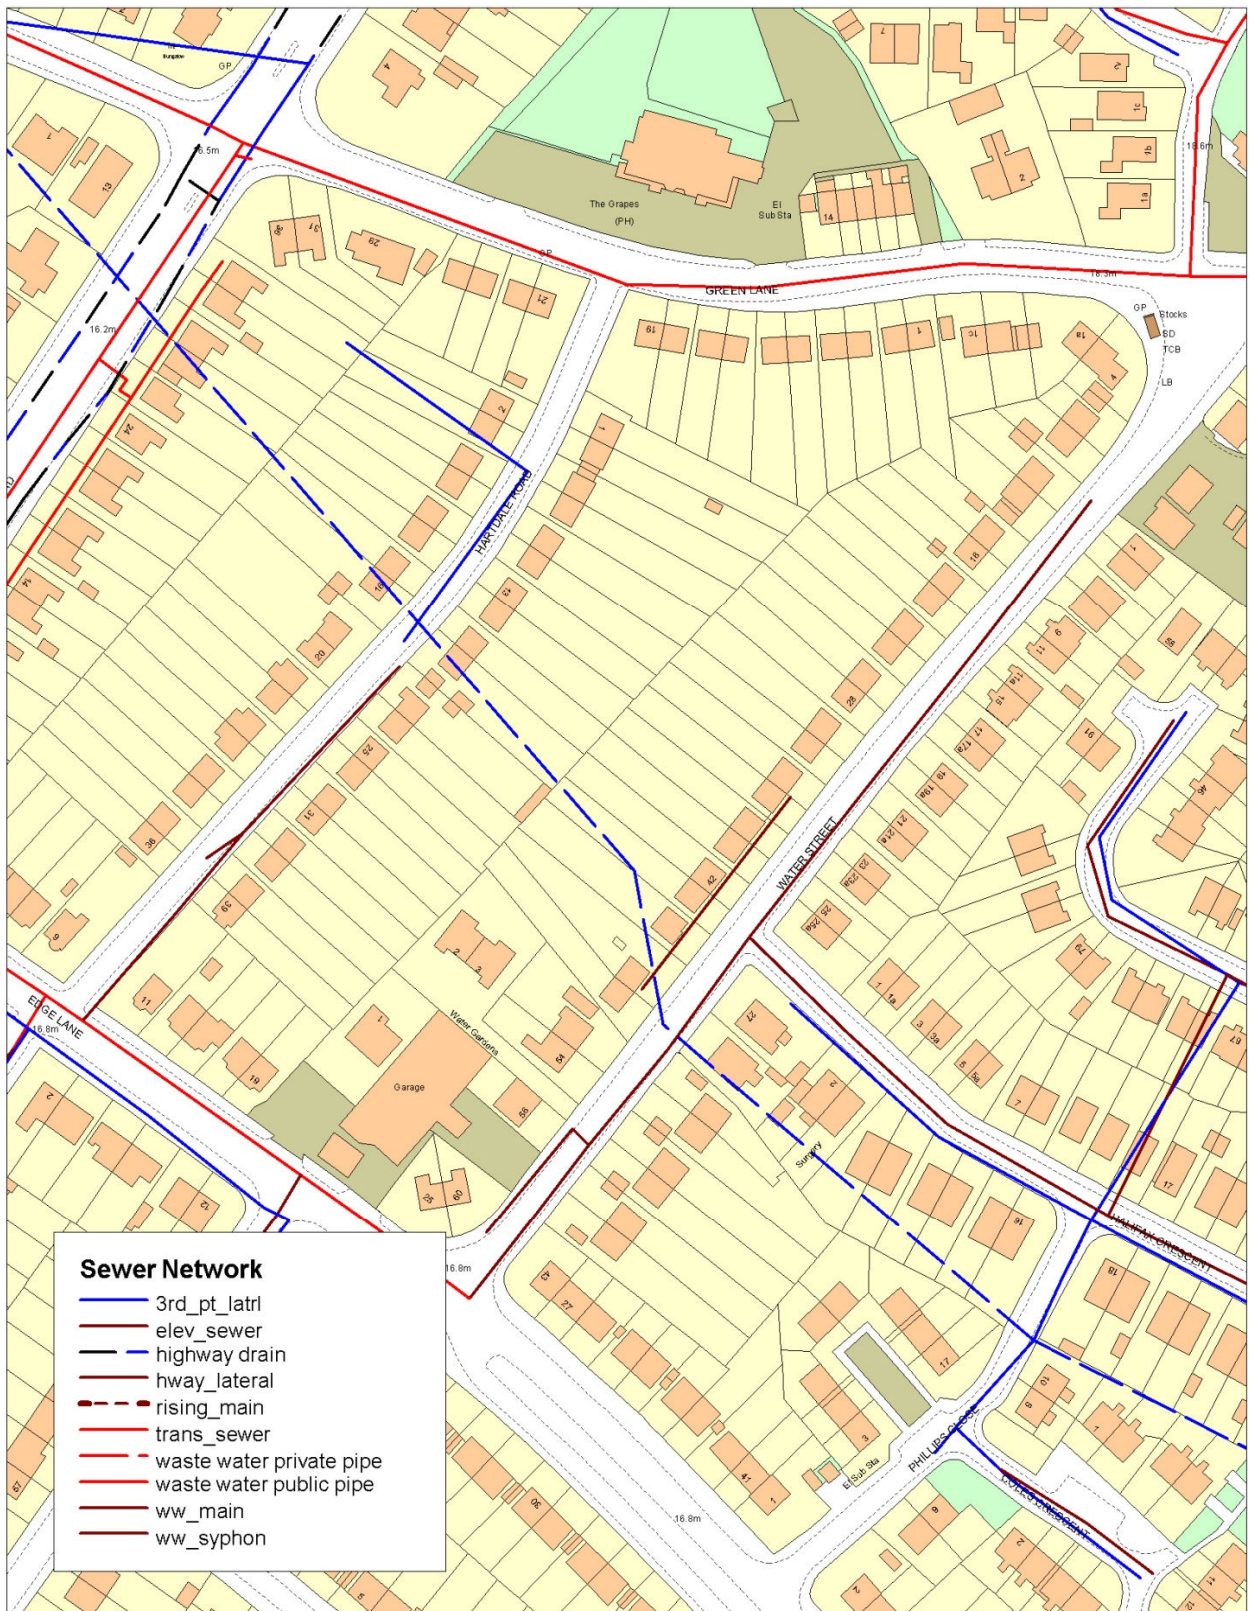
Figure 21: Water Street, Thornton – sewer network

Surface water from the area is discharged either directly from the highway drains or via the public sewer (shown as the blue line on the Figure 20), into a piped watercourse that flows from Runnels Lane to Brook Road and discharges into a watercourse which flows into Hunts Brook and then into the River Alt and then into the Mersey Estuary via Altmouth Pumping Station at Hightown.

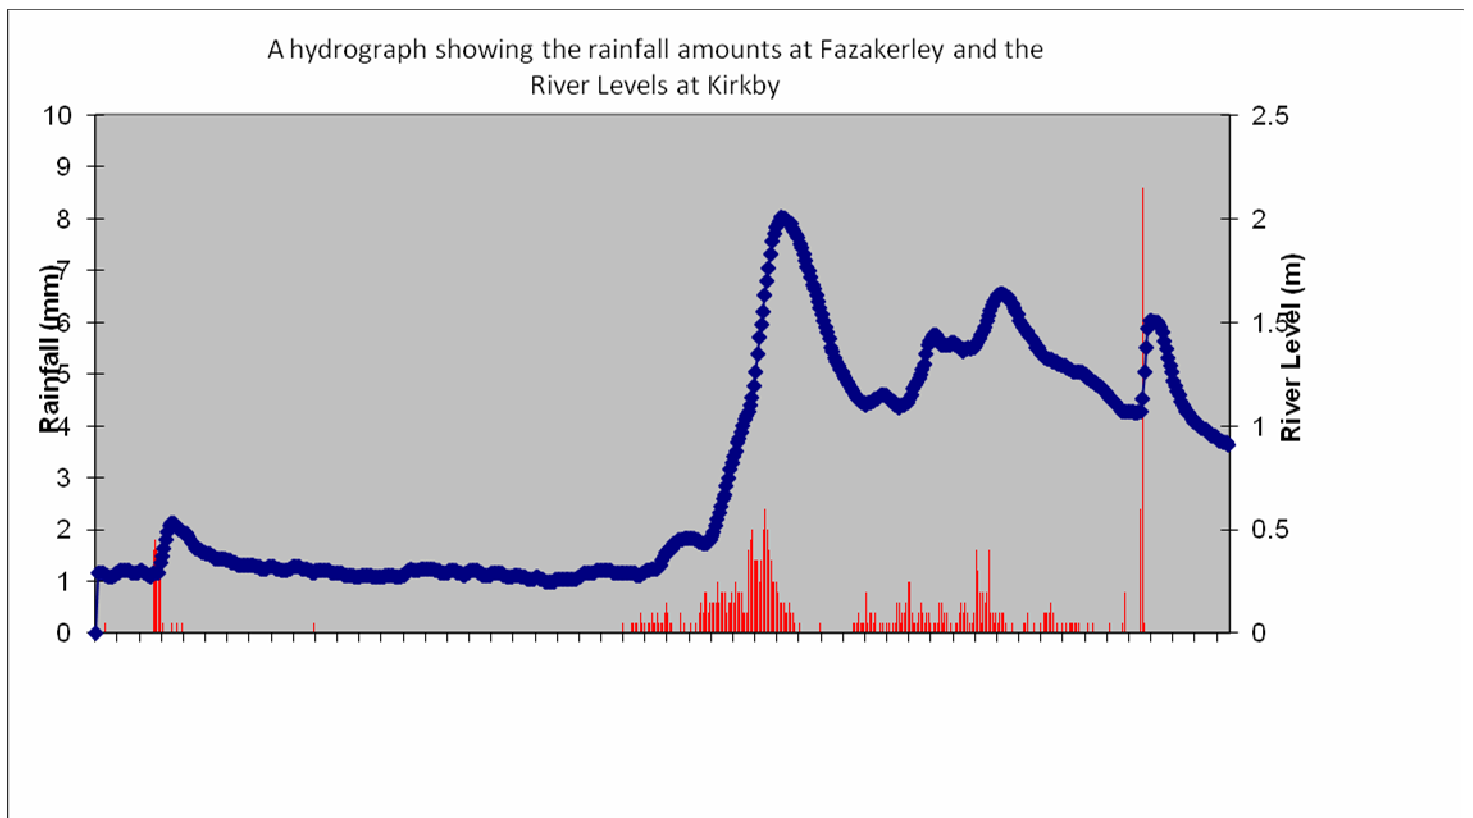
In response to the heavy rainfall the River Alts levels, measured at the Environment Agency's Kirkby gauging station, rose from 0.285m at 21.00 on the 23rd and peaked at 2.01m at 15.45 on the 24th September, as shown in the graph below.
